**Master's Thesis 2018 60 ECTS**

# **Responses in Fish and Macroinvertebrates to Channelization and Restoration in two Arctic Rivers.**

**Andreas Lium**

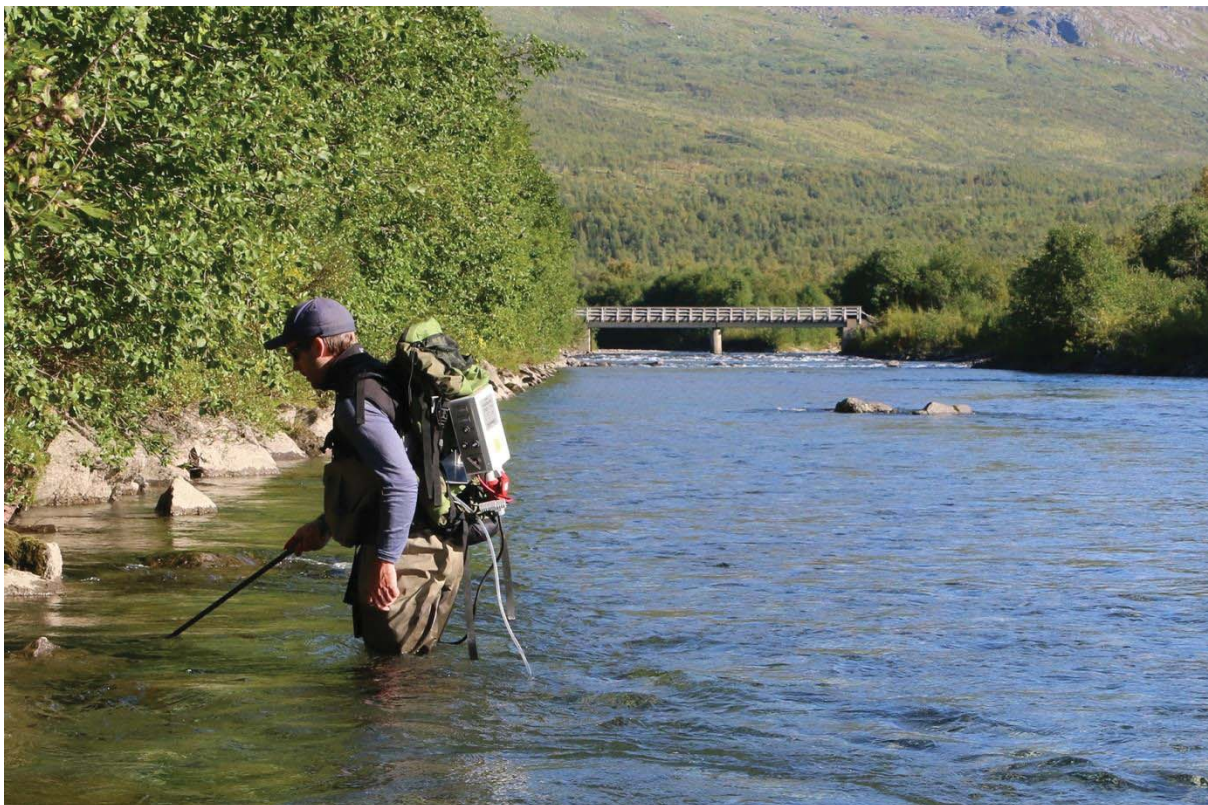
Figure 11. Photograph of electrofishing in the main river channel in Salangselva, Bones. Photo: Geir Dahl-Hansen 2017.

In the Bones area of Salangselva, the main river channel was electrofished along the bank (Figure 11). The Storøra meander and Budalsfaret tributary were easier to electrofish more thoroughly because of the shallower water. In addition to the aforementioned replication of previous studies done in the area, I also electrofished one station in the tributary Budalselva, two stations in the tributary Stordalselva, as well as one station further downstream at the northern boundary of the study area. Due to the low densities of fish to be found, only one pass of electrofishing was conducted at all stations, assuming 50% of fish present at the station being caught and registered (Strann et al. 2010). Catches were stored in a bucket until the electrofishing of one station was completed, and then measured to the nearest millimetre before being released.

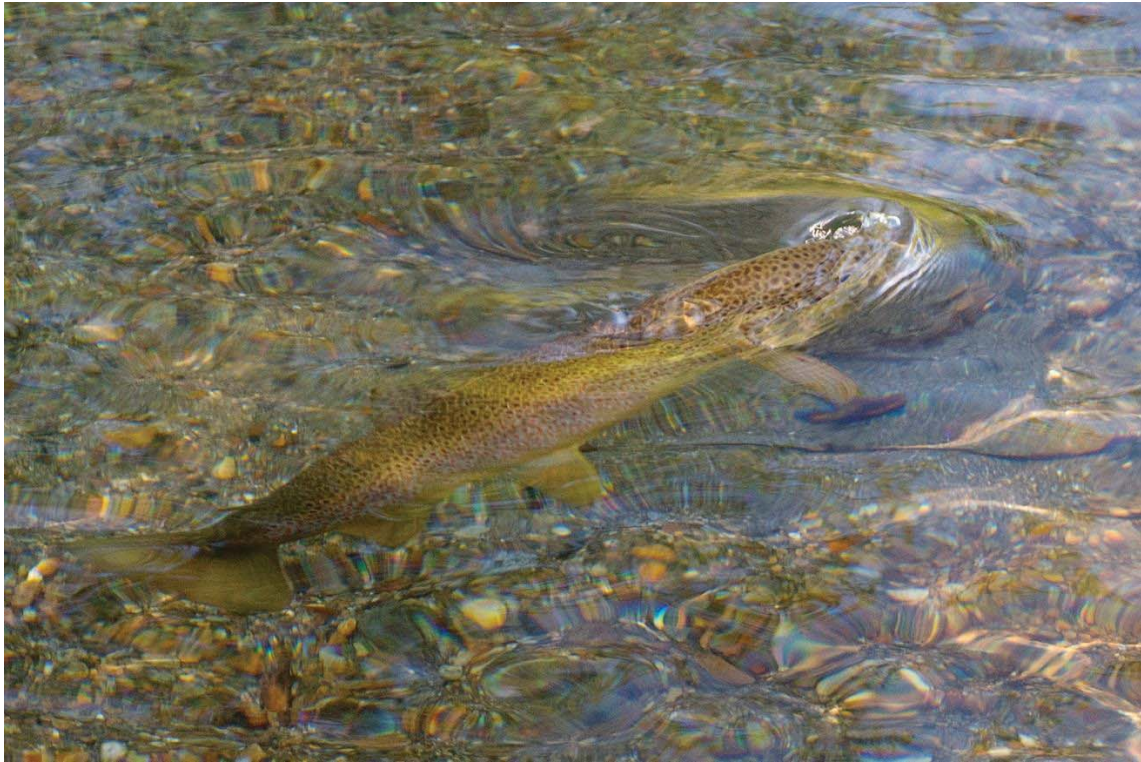
Figure 12. Photograph of a brown trout (approx. 45cm) observed actively surface feeding on adult mayflies in the Baetidae family, Kvernmoelva.

In addition to electrofishing, visual observations of older and larger fish was possible in Kvernmoelva during both periods of fieldwork (Figure 12). This was done wearing polarized sunglasses on sunny days, and conducted in the entire study area.

During the first period of fieldwork, water levels were fairly high in Kvernmoelva due to the late snowmelt in Troms in 2017. A total of seven ~2lbs brown trout were observed, and only two of them in the channelized stretch of the river (Figure 28). These two brown trout were seen actively feeding (Figure 12) on small mayflies (Baetidae) in the lowermost parts of the channel. When spooked, they both fled downstream to the nearest deep refuge at the beginning of the naturally meandering part of the river. During the second period of fieldwork, water levels were lower. Only

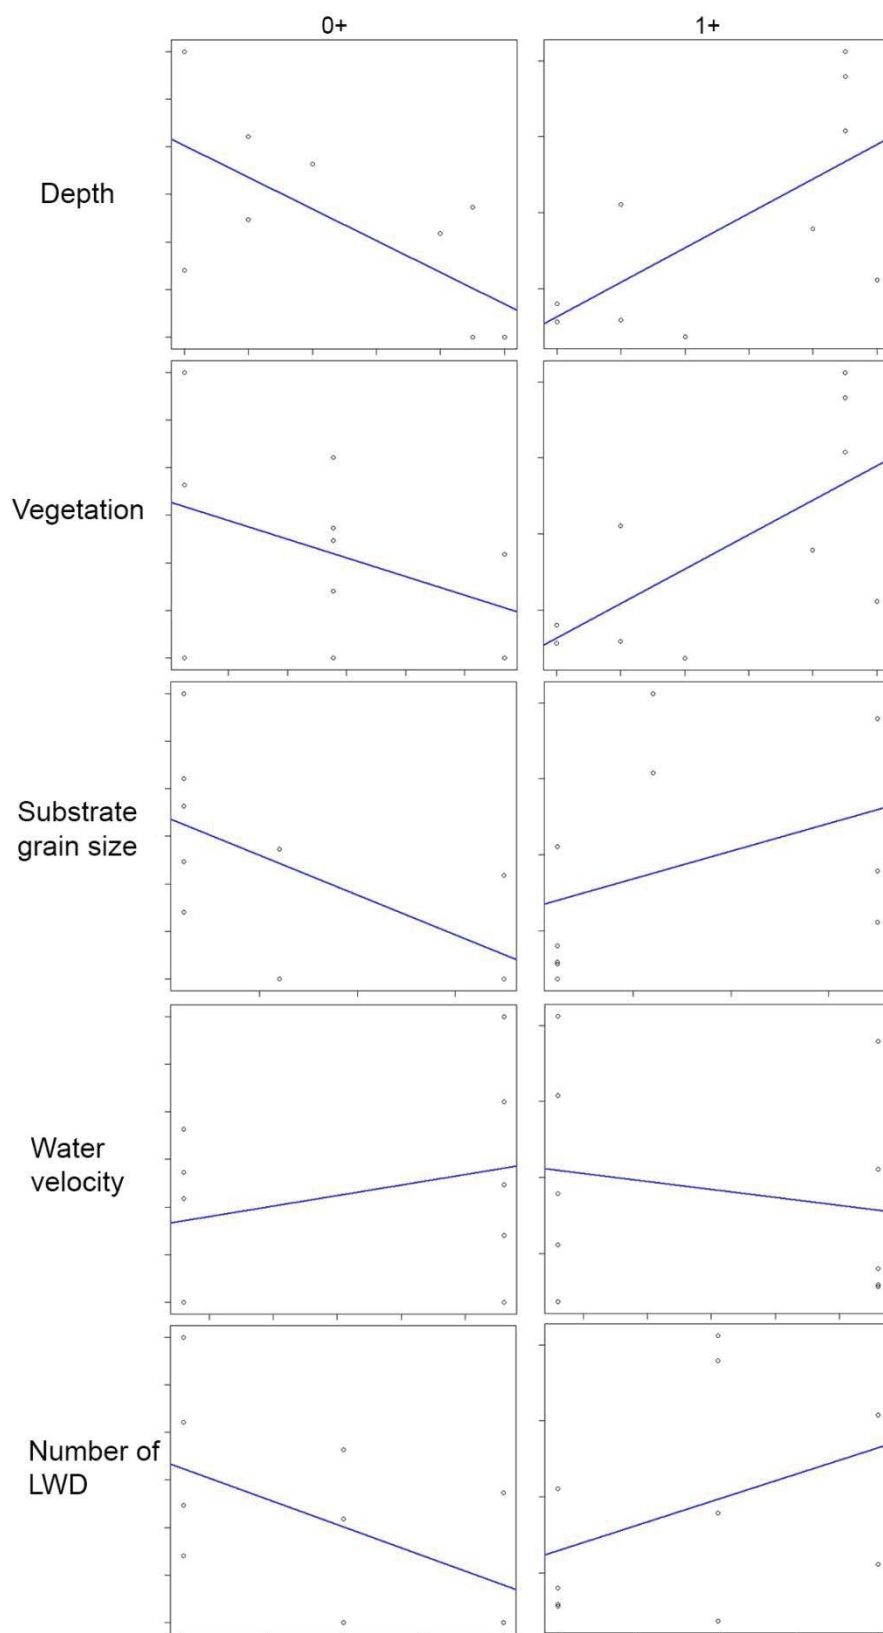
Figure 18. Associations between estimated densities of brown trout (y-axis) in Kvernmoelva, and the different environmental variables (from top to bottom); depth, vegetation, substrate grain size, water velocity and number of large woody debris. Upward sloping trend-line represent a positive relationship, and vice versa.

Plots of estimated brown trout density explained by single predictor variables for the 0+ and 1+ brown trout age classes in the entire Kvernmoelva study area reveal opposite trends for 0+ and 1+ (Figure 18). The corresponding coefficients are summarized in Table 9, where the most interesting and only significant relationship is density ~ Depth for both age classes.

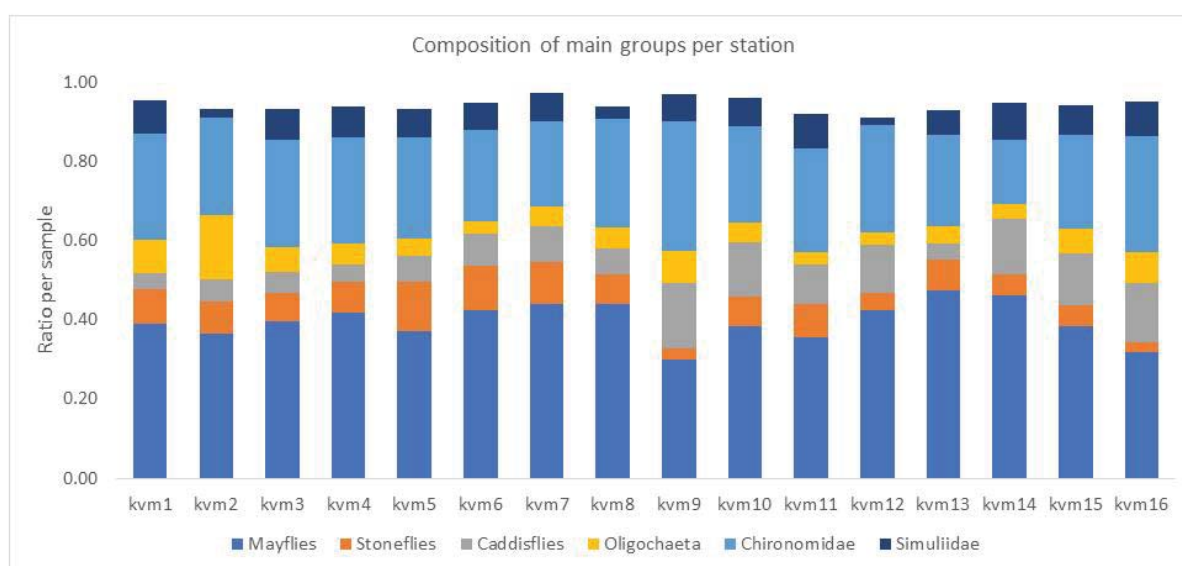
Figure 20. The composition of main groups of benthic macroinvertebrates for each station in Kvernmoelva. Kvm1-kvm8 is in the channelized stretch, and kvm9-kvm16 is in the naturally meandering stretch of the river.

Exploring this further by looking at benthic macroinvertebrate community composition at each station, did not reveal any interesting differences between station 1-8 (channel) and station 9-16 (natural) (Figure 20).

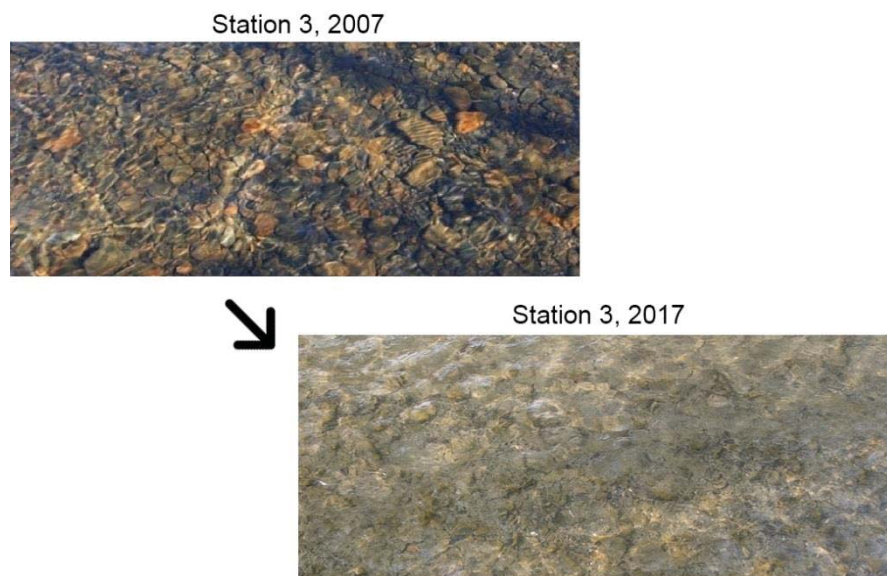
Figure 22. Bottom substrate at station 3 («Budalsfaret 2»). Photograph from 2007: Geir Dahl-Hansen.

Due to a high sediment load and low flow, fine sediment settled on the stream bottom in Budalsfaret (Figure 22; Figure 23).

photographs reveals a change in the bottom substrate for the other two sampling stations in Budalsfaret. Silt had covered most of the substrate visible on photographs from 2007. Sedimentation of fine particles degrades interstitial space habitat important to benthic macroinvertebrates (Gayraud & Philippe 2003; Harrison et al. 2007), and may cause anoxic conditions in the bottom substrate (Massa et al. 2000). This would explain the negative trend in ecological condition in Budalsfaret. No previous sampling of benthic macroinvertebrates has been conducted in the main river channel.

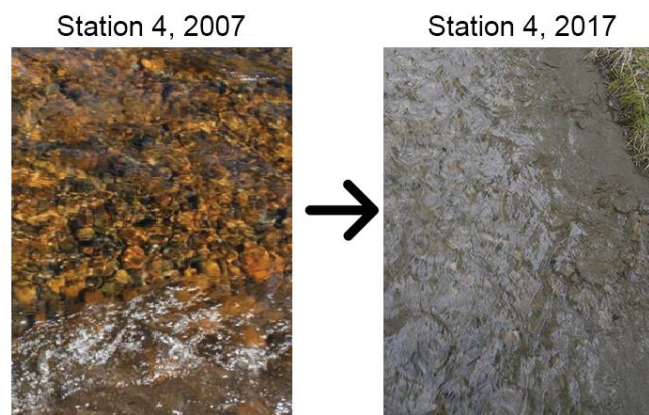
Figure 23. Bottom substrate at station 4 («Budalsfaret 3»). Photograph from 2007: Geir Dahl-Hansen.

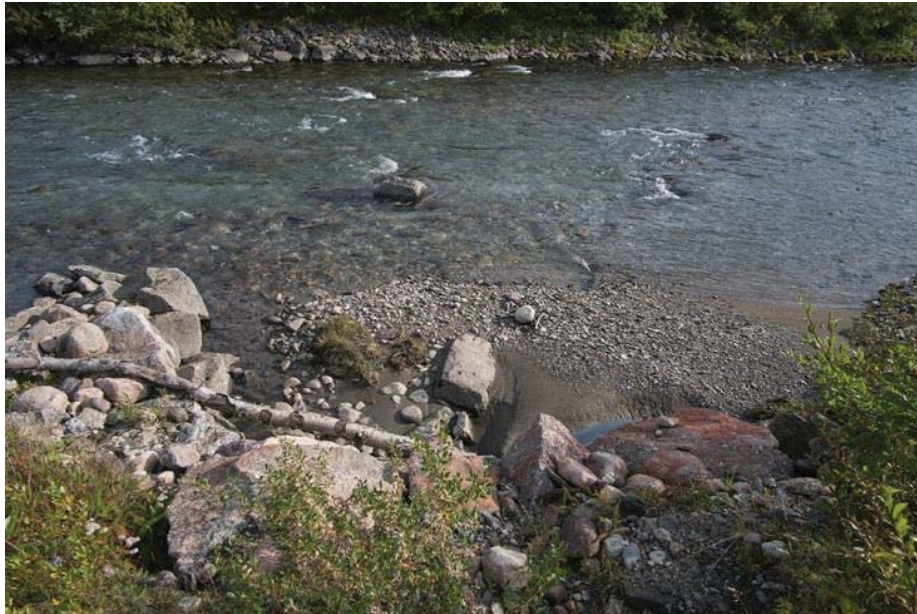
Figure 24. The intake at Gåsodden, where the intake is constructed at a 90 degree angle to the main channel. Location indicated with a «G», on the map of the Salangselva study area in Appendix C2.

Accumulation of sand, gravel and cobble is problematic when intakes are constructed at a 90 degree angle to the main channel. Turbulence leads to accumulation of sand and gravel, and effectively blocks the flow of water (Figure 24; Figure 25).

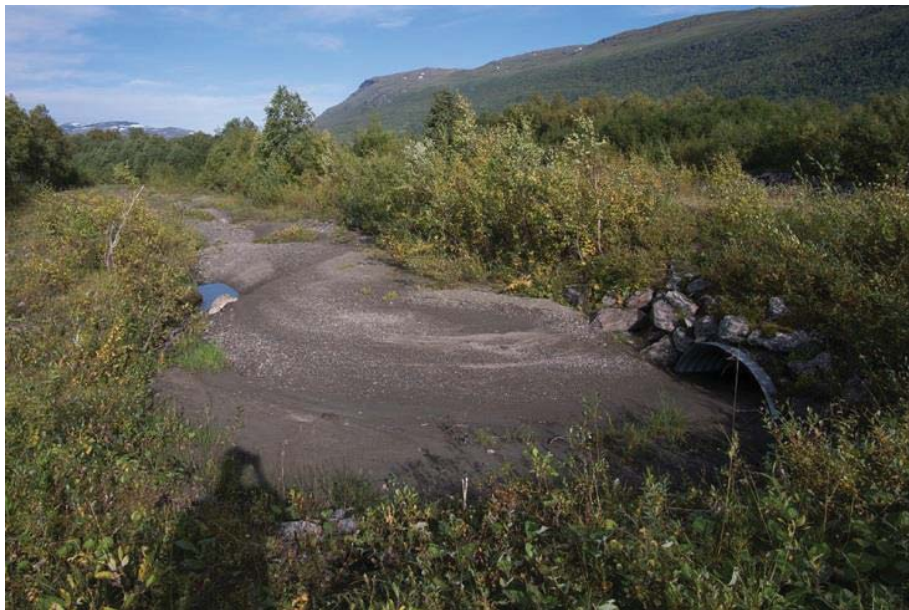
Figure 25. The reopened tributary at Gåsodden, where the intake causes accumulation of sand, gravel and cobble.

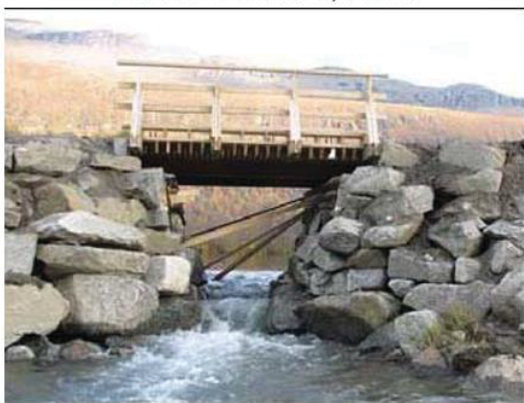
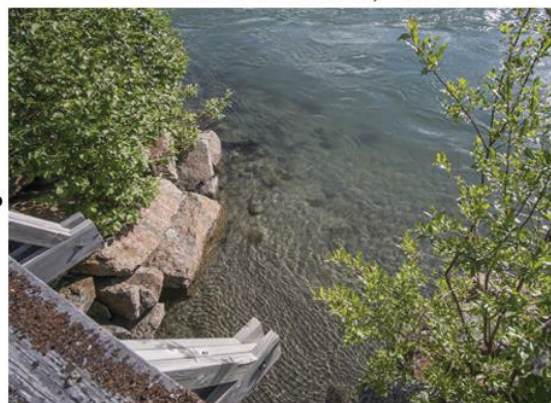
Figure 26. The outlet of Storøra, where sand accumulates due to low flow through the meander and into the main channel. Photograph from 2007: Geir Dahl-Hansen.

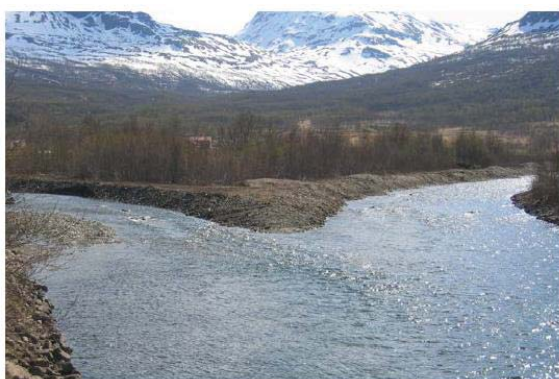
Figure 27. From 2007 (left) (Hoseth, K. A. 2017) just after the removal of erosion protection structures along the bank, and 2017 (right) where vegetation has recolonized – effectively reducing erosion naturally.

Erosion protection structures were removed along the bank at the junction between Budalselva and Stordalselva in order to reduce stream velocity and support natural river processes (Hoseth, K. A. 2017) (Figure 27).

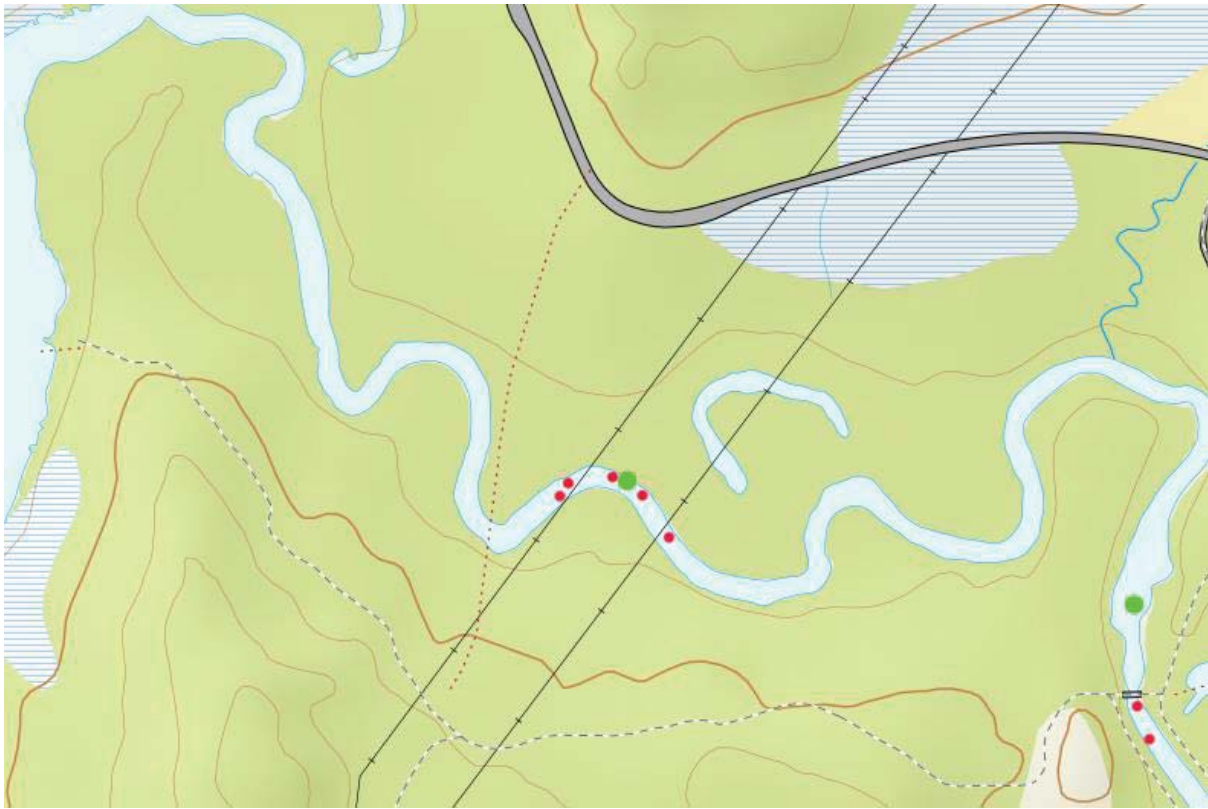
Figure 28. Observations of ~2lbs brown trout during the first (red dots) and second (bright green dots) period of fieldwork. Bjørnarvatnet to the left ([www.norgeskart.no](http://www.norgeskart.no)).

two ~2lbs brown trout were observed in the Kvernmoelva study area (Figure 28), both in the naturally meandering stretch of the river.

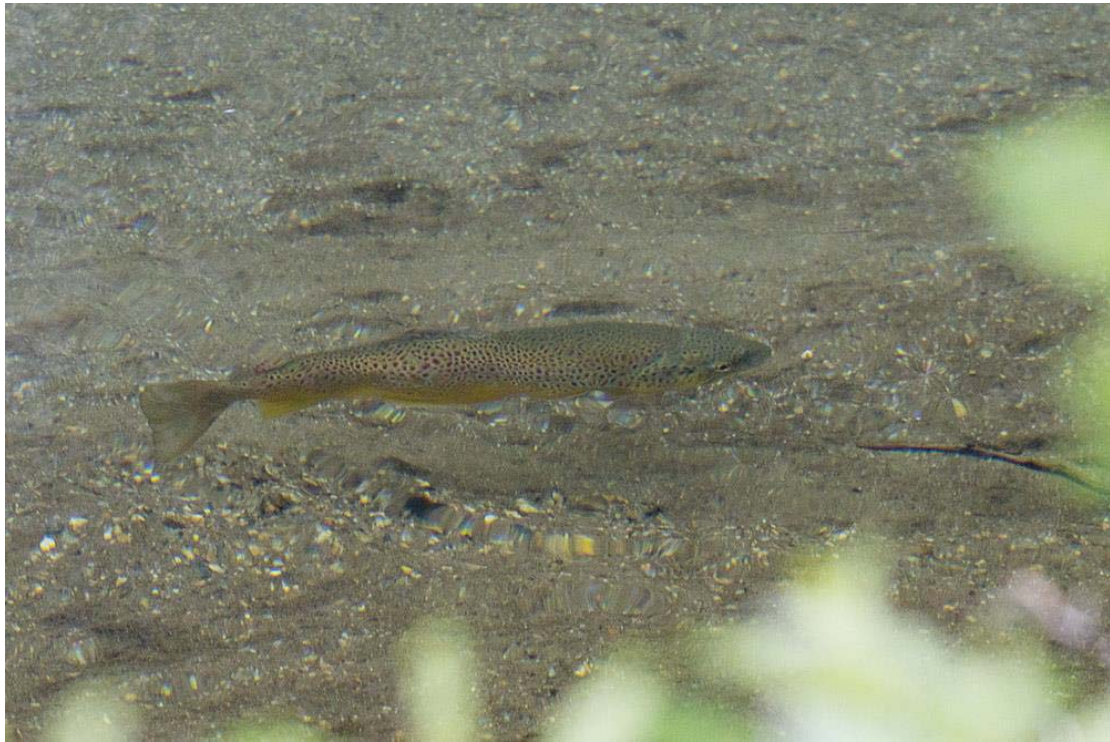
Figure 29. Larger brown trout (~2lbs) observed in the naturally meandering stretch of Kvernmoelva.

Larger fish (~2lbs) were observed in the naturally meandering part of Kvernmoelva (Figure 29). Seven during the first period of fieldwork (25-31 Jul.), and only two during the last period of fieldwork (25 Aug. – 5 Sept.). Only two of the larger trout were observed in the channelized stretch of Kvernmoelva. Their location in the lowermost part of the channel at the time of observation can possibly be explained by the high concentration of food during a hatch of the mayfly *A. Inopinatus*. Both fled downstream when spooked, to the nearest deep refuge in the naturally meandering part of the river. From my visual observations and previous knowledge on brown

trout behaviour, I suggest that larger brown trout from Bjørnarvatnet migrate in and out of the river Kvernmoelva, using it as feeding grounds during early summer and spawning grounds in the autumn.

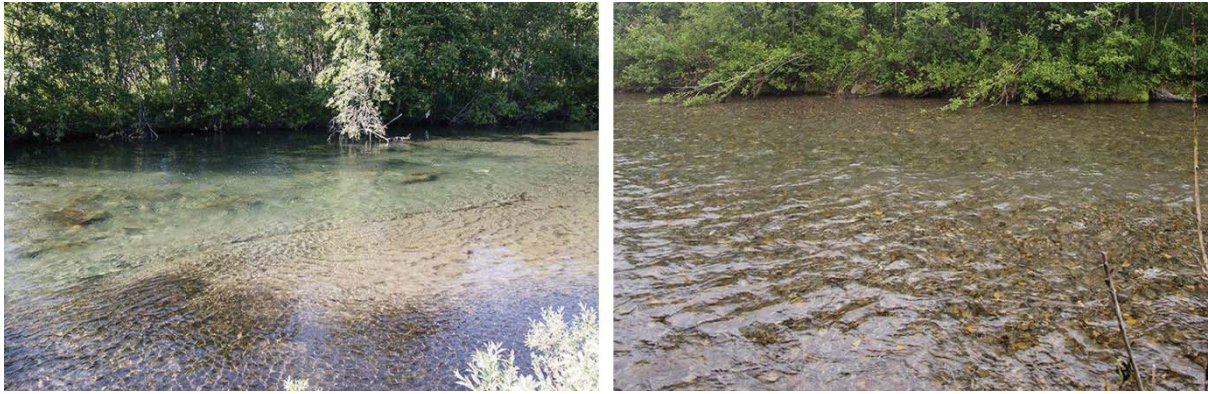
Figure 30. Scattered boulders clearly visible in a pool in the naturally meandering stretch of Kvernmoelva (left) where sand is the dominating bottom substrate grain size, and homogenous gravel bottom substrate in the channelized stretch of Kvernmoelva (right).

Most juvenile brown trout caught and registered in the Kvernmoelva study area were associated with hiding places under or between cobble and boulders. The registered bottom substrate at each station was the dominating grain size, thus the low power of the variable substrate in the statistical analysis might be misleading. Scattered cobble and boulders were more numerous in the naturally meandering part of the river than in the channel (Figure 30). In addition, fine-scale variation of the variables LWD and water velocity might have been lost during the registration of means within each station. Observations indicate that there were indeed more coarse organic material, boulders, and variations in water velocity both horizontally and vertically in the naturally meandering stretch of the river compared to the channelized stretch of the river – as would be expected.

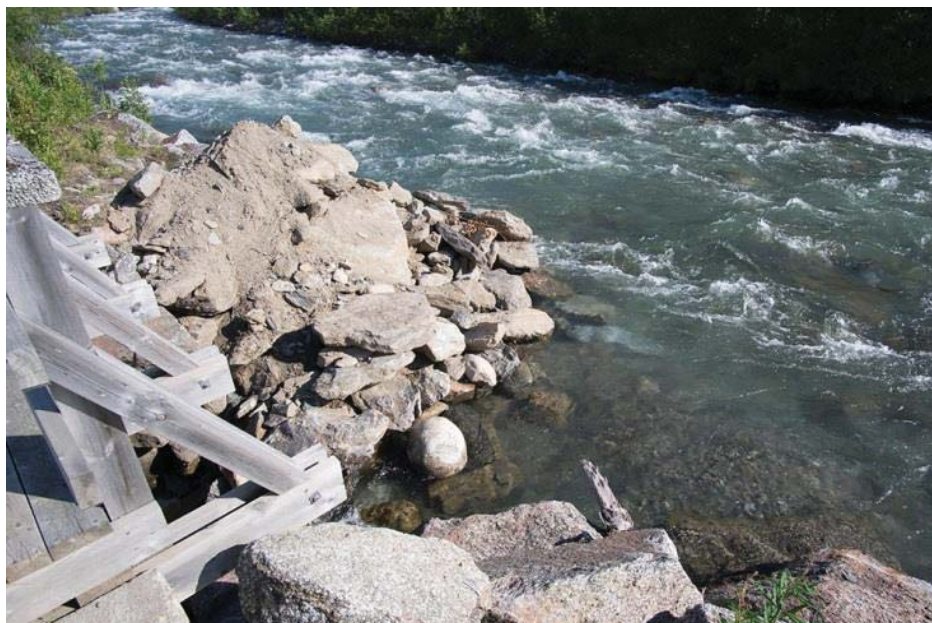
Figure 31. Boulders blocking the intake to Budalsfaret, due to fear of a destructive flood.

Regarding Budalsfaret and the Storøra meander, the high rate of silt sedimentation and periodically low flow conditions appear to be detrimental to these areas as both juvenile brown trout and benthic macroinvertebrate habitat. The bottom substrate in the tributaries Budalselva and Stordalselva appeared unstable and sterile, much like the substrate in the main river channel. Due to local farmers worrying about a destructive spring flood in 2017, much of the intake of water from Budalselva into the Budalsfaret tributary were blocked by a truckload of boulders (Granheim, T. J. 2017, The Norwegian Water Resources and Energy Directorate (NVE), pers. commun.), from June through the entire study period (Figure 31). This might have caused juvenile brown trout to disperse away from the Budalsfaret tributary and the Storøra meander due to low flow, prior to sampling being conducted.

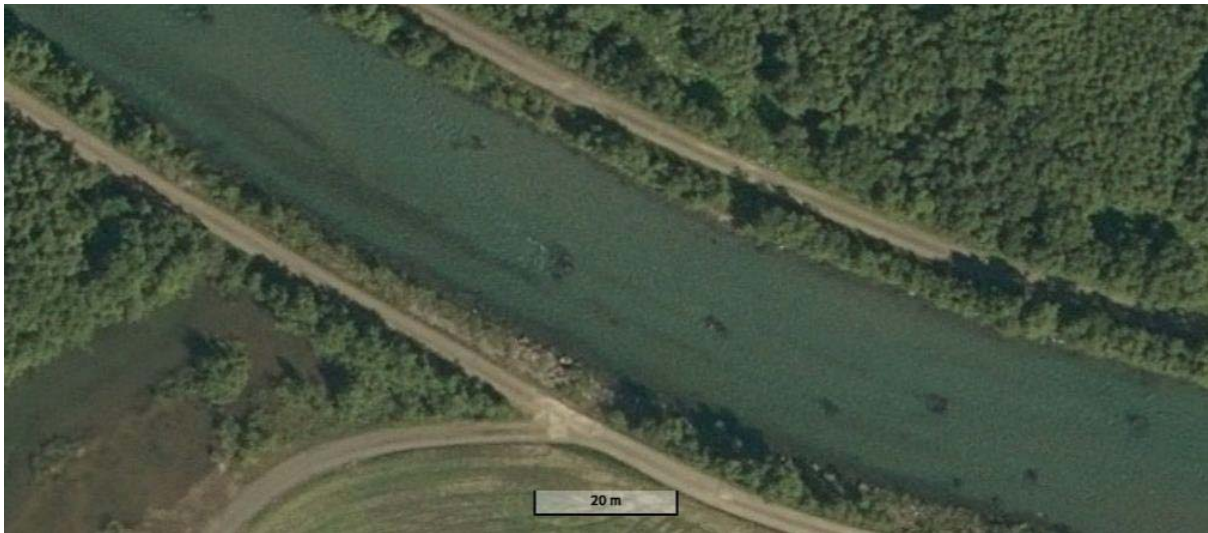
Stone groups in the main river channel at Bones, seen from above ([www.norgeskart.no](http://www.norgeskart.no)).

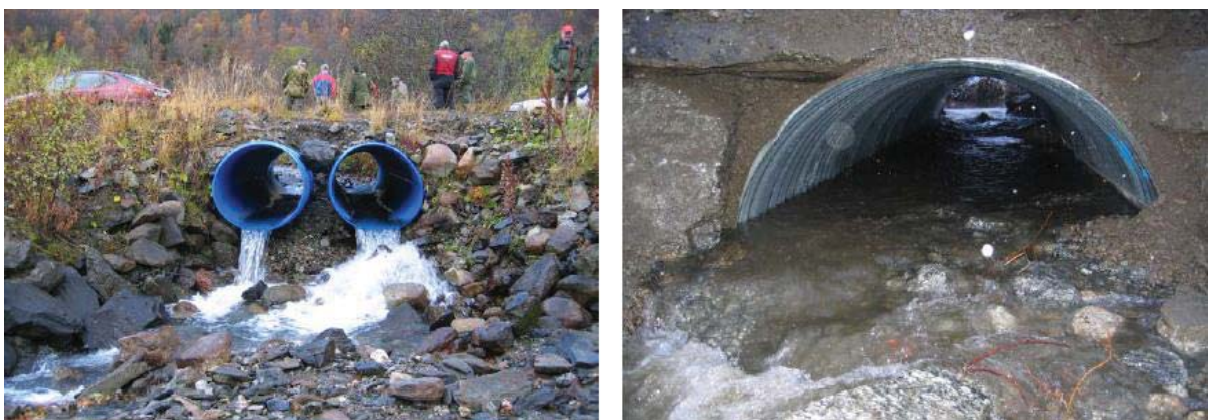
Culvert constructions at Bones; old (left) and new (right). New culvert construction facilitating the movement of organisms between the main river channel and its tributary (Hoseth 2017).
