Norwegian University
of Life Sciences

Master's Thesis 2020 60 ECTS

Water quality affected by interactions with filter media in raingardens

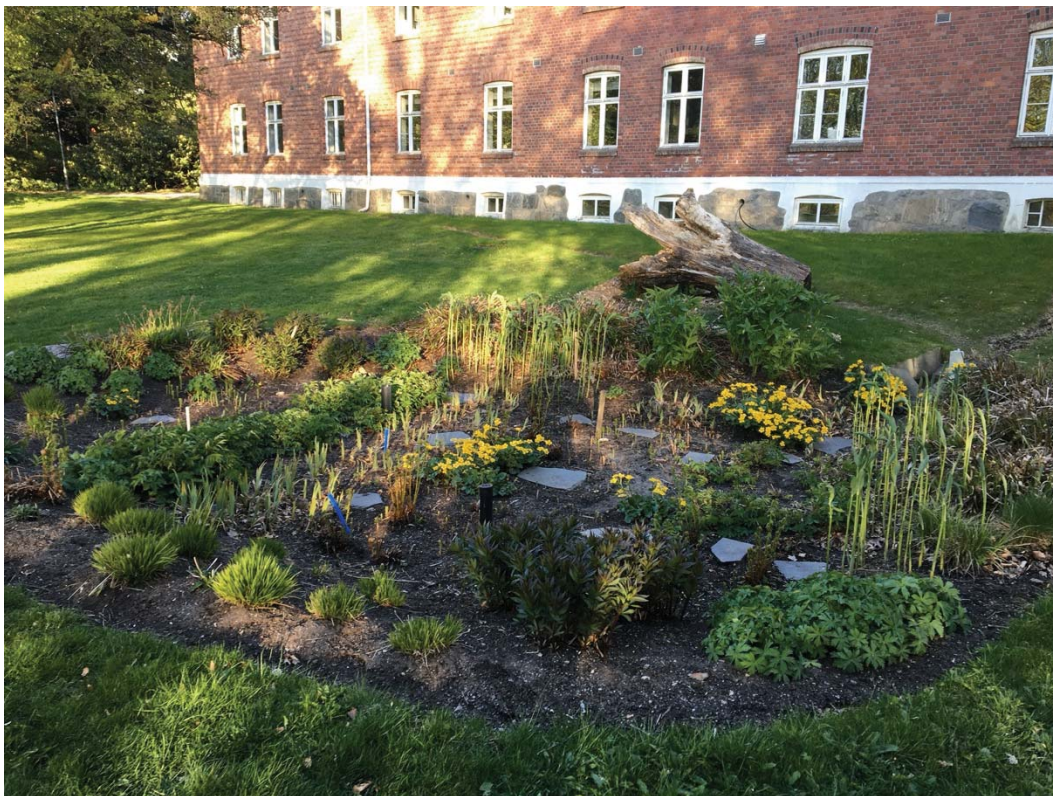
Figure 1.3 The NMBU research raingarden with the building Tivoli in the background, spring 2020.

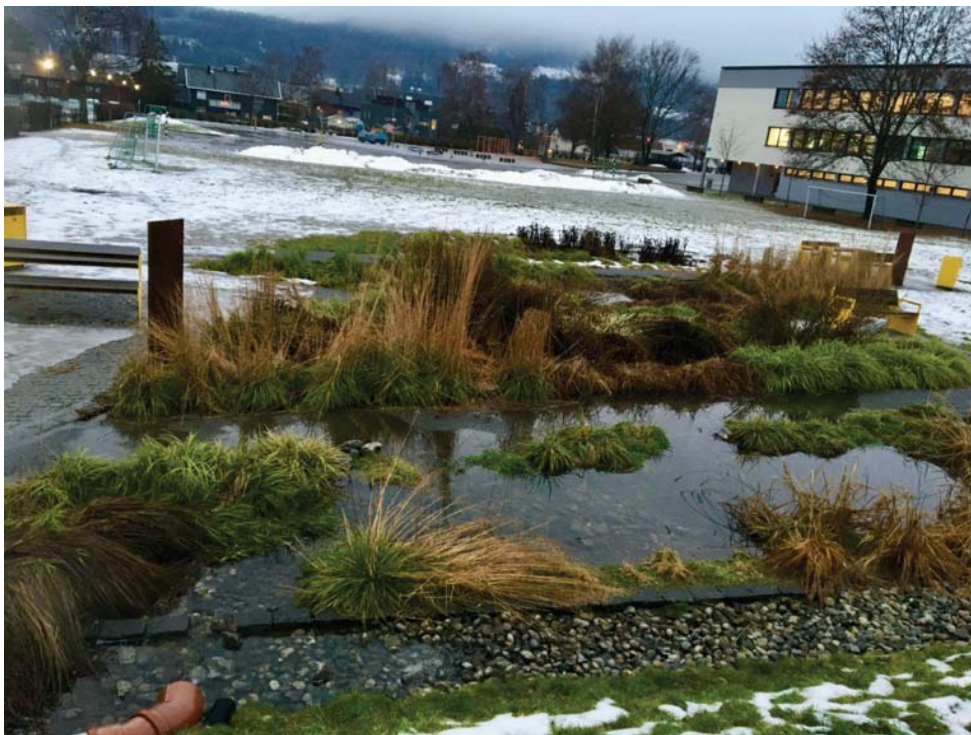
Figure 1.5 Bolstadhagen raingarden 13. December 2019. Raingarden 1 is in the front and raingarden four is furthest away. Kjøsterud ungdomsskole can be seen in the background.

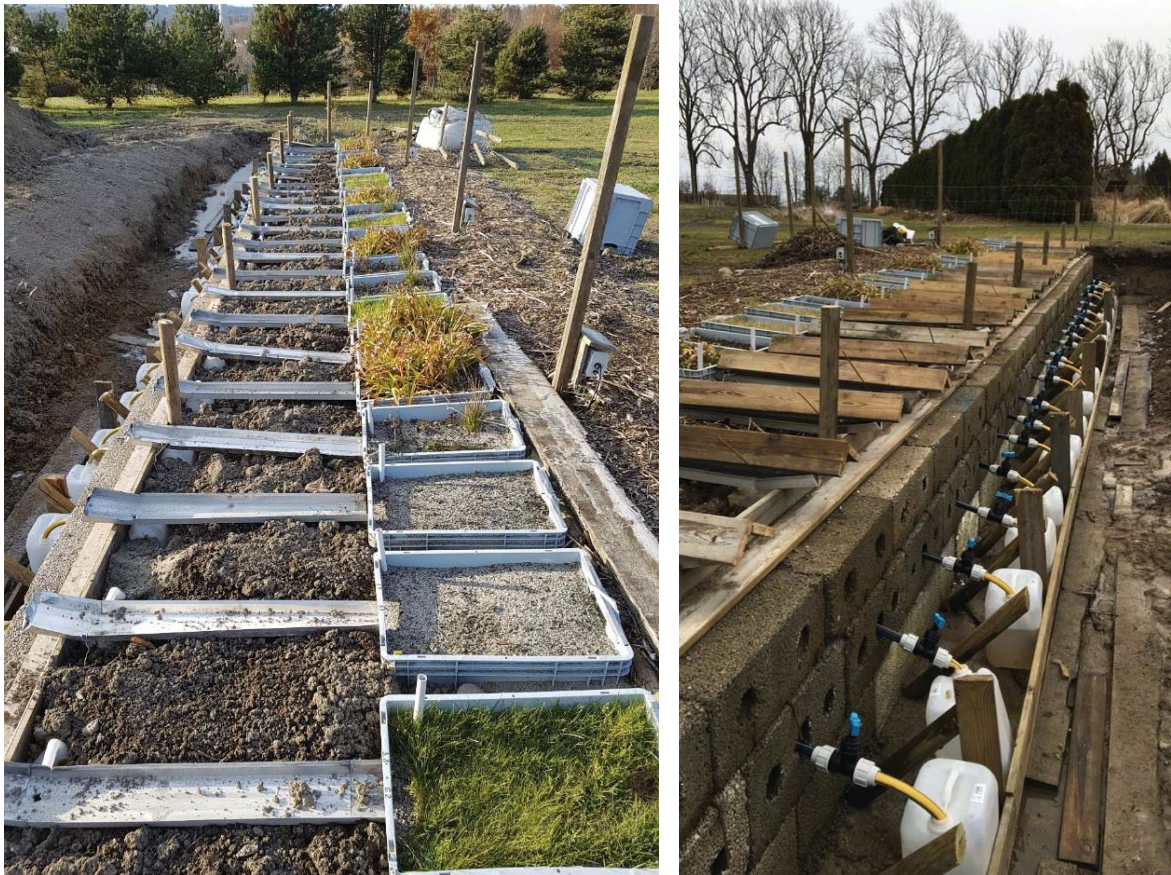
Figure 1.10 Mesocosm set up at Planteskolen, NMBU. Right picture show top of plant boxes and surface runoff system left picture shows system for collection of drained water. (right pic. Marina Bakhtina 5. Nov 19)
