Norwegian University  
of Life Sciences

**Master's Thesis 2020 60 ECTS**

# **What's Rocking in Bognelv? A Case Study in Hydromorphological Conditions Before, During and After Restoration of a Channelized River by Studying Tracer Rocks and Aerial Photos**

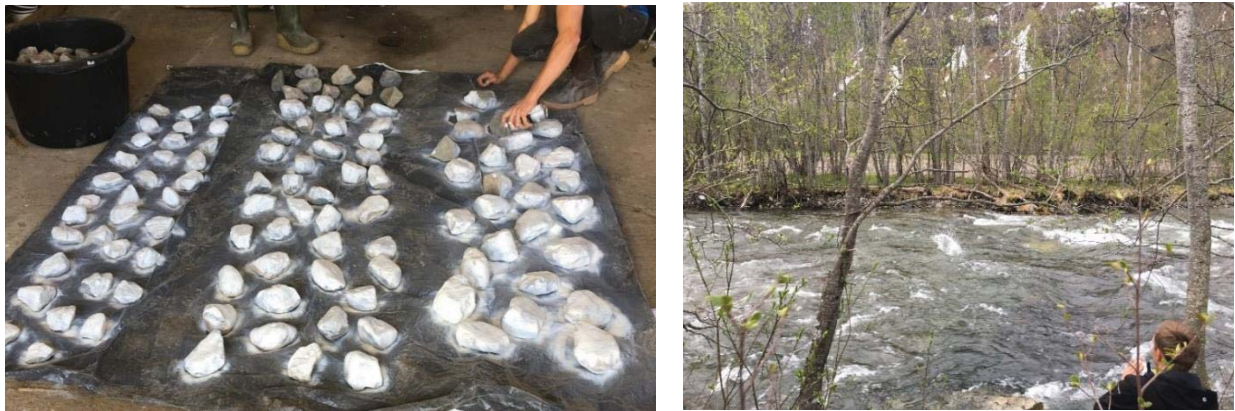
Figure 3. Left: Photograph of painted white rocks that have an inserted pit-tag, and divided into rows of each of three weight classes. Right: Releasing of rocks in field. Picture is taken at station 5.

The rocks were then “released” at the six stations. Due to high discharge during the time of field work, 17.31 m<sup>3</sup>/s (Figure 7), the well consolidated rocks were placed across the river by a way of randomly lobbing them out (Figure 3). Since the conditions were unconstrained and rocks were not arranged and pressed into the bed by hand (constrained conditions), the tracer

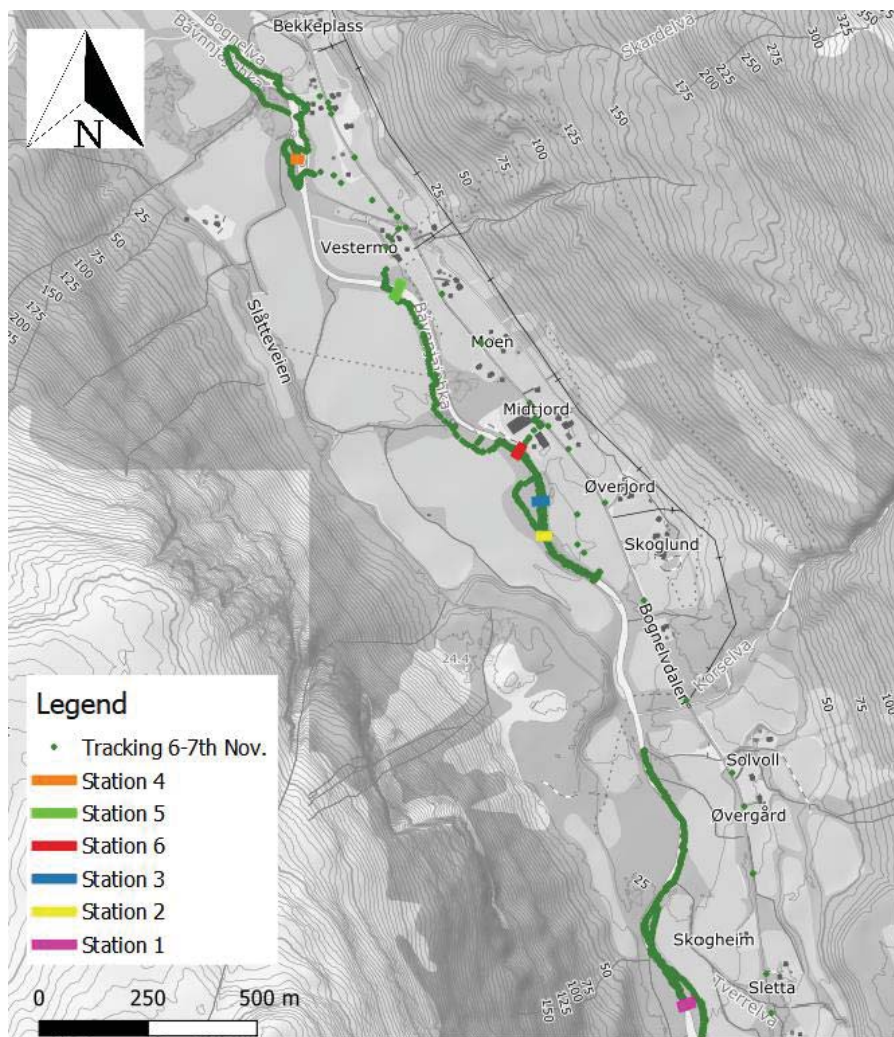
Figure 4. Tracking data from the handheld GPS from registration in November, when the portable PIT antenna was used.

Registration, and relocation of the tagged rocks took place after 6 months (6-7<sup>th</sup> November). Relocating the marked tracer particles after their transport is technically simple, but time consuming, and depends on weather conditions. Detection is easier to complete at lower amounts of water; therefore I waited until early November (7-8<sup>th</sup> of Nov). However, winter came early to Bognelv in 2019. During fieldwork, temperatures dropped to -20 °C with combined snowfall. Parts of the river bottom froze, making it slippery to walk the entire width of the river and register. Side channels were partly frozen making it easier for registrations through the ice (Figure 5). At the three lowest stations -3, 5 and 6- the river was partly ice-covered, but the ice was not thick enough to walk on, and the pressure from floating ice made the pools even deeper. Due to these conditions, the entire river was not sampled during this round (Figure 4).

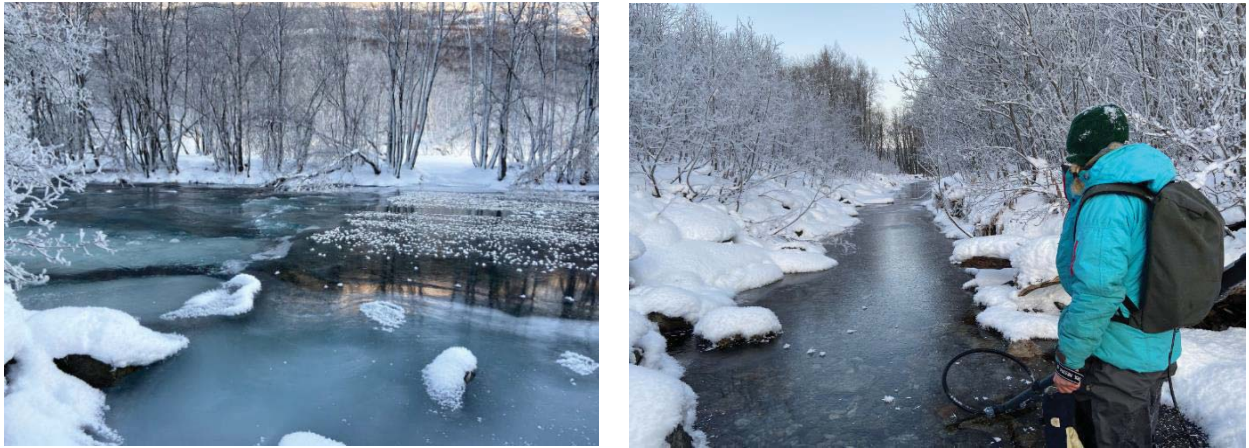
*Figure 5. Left: Station 5. With this onset of freezing water and uncertain ice conditions, it was impossible to register traced rocks at this station. Right: Station 2. Solid ice made it possible to scan the side channel (notice the portable antenna).*

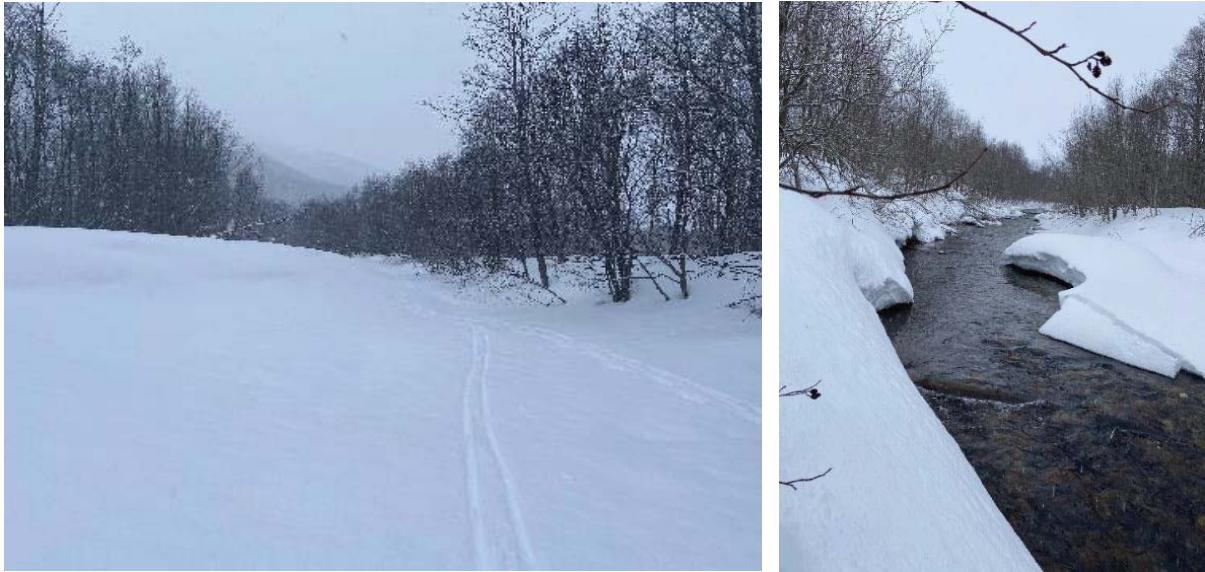
*Figure 6. Left: A picture of the snow cover at station 6 in February. Snow depth measured over 1 meter, so no rocks could be registered through the snow. Right: Picture from station 5 shows how difficult conditions were in February for another possible round with registration.*

In hope of a solid ice-covered river, a new registration round began in February. PIT-tags can also be registered through ice and snow cover, as long as it is not thicker than the detection range of the antenna (Linnansaari et al., 2007). In December 2019 and February 2020, the closest weather station, Sopnesbukt, measured around 192 cm of snow (yr.no). Due to snow amount and wind drift, parts of the river had snowdrift higher than 1-2 meters, while parts of station 6 were open (Figure 6). The antenna was tested and capable of registering visual rocks seen at station 6, but was not able to register through the high snow cover at station 5.

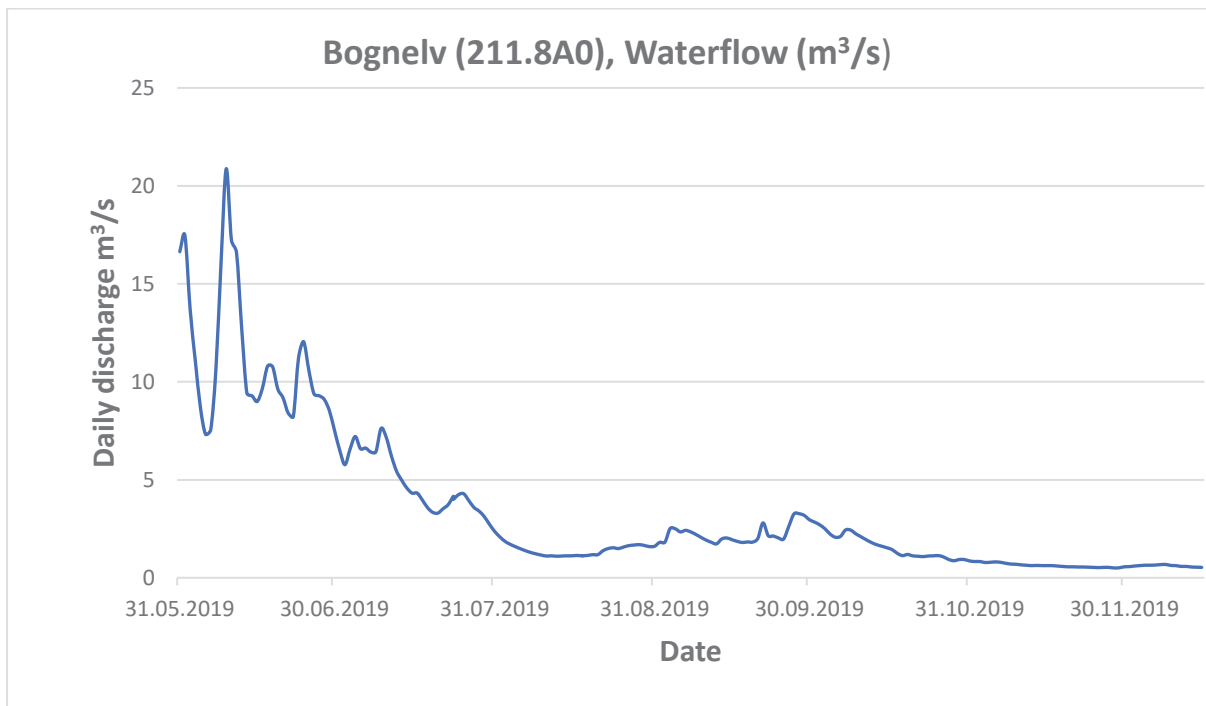
Figure 7. Hydrological graph showing the daily average water flow ( $\text{m}^3/\text{s}$ ) in Bognelv in the period from May-November. Highest peak June 13, 11.00 am ( $32.42 \text{ m}^3/\text{s}$ ), and average flow ( $3.44 \text{ m}^3/\text{s}$ ). Numbers are correlated from the nearest station, Halsnes (212.49). Note that the rocks were released on May 31, almost two weeks before the highest water flow episode in June 13

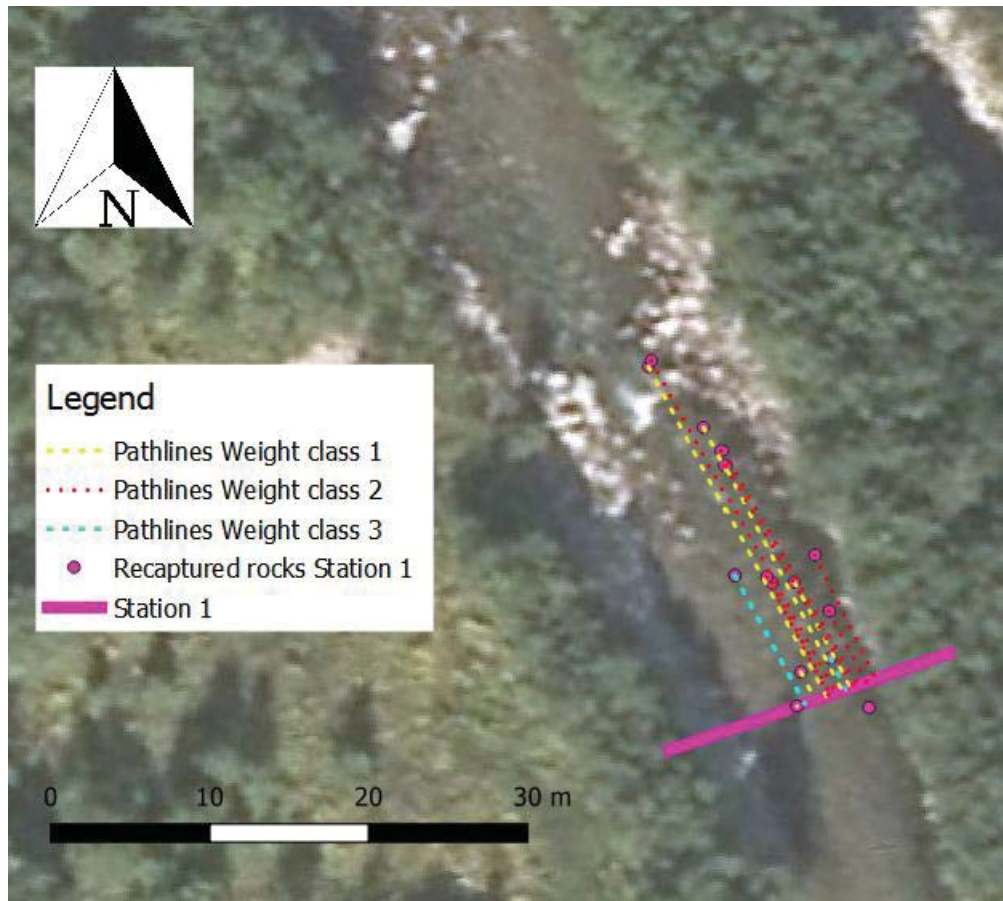
Figure 4. Overview map showing travel path for traced rocks at station 1. The pink starting line is where rocks were released, and pink dots are where they were recaptured. The colour of the path lines indicates what weight class each recaptured rock belongs to.

Station 1 was the uppermost station in the river, zone 8 (Figure 2), related to restoration measure 7, located below Øverplasselva (Tabel 1) (Appendix 1). A total of 17 rocks were released in the river (Table 2), and 17 rocks were recaptured, a recovery rate of 100%. One rock was by mistake released above the starting line and has no registered travel distance. Figure 8 shows the travel path for each rock from where it was released (pink line) and until it was recaptured. Weight class 2 (0.7-1.8 kg) had the longest average transport length in the months from May- November with a movement of 11.6 m (Table 4).

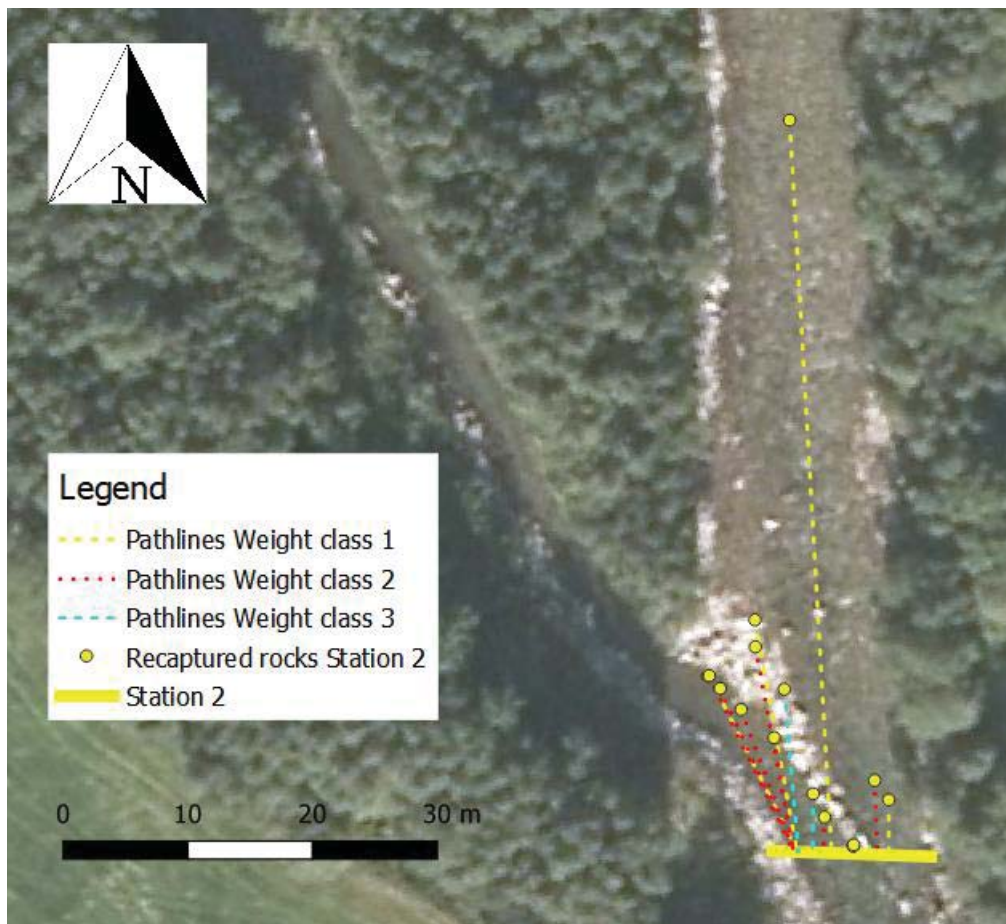
*Figure 9. Overview map showing travel path to traced rocks at station 2. The yellow starting line is where rocks were released, and yellow dots are where they were recaptured. The colour of the path lines indicates what weight class each recaptured rock belongs to.*

Station 2 (Figure 2) was related to restoration measure 5 (Table 1) (Appendix 1). 18 rocks were released and 16 rocks were recaptured, a recovery rate of 88%. Figure 9 shows the travel path to each rock from when it was released, and until it was recaptured. Weight class 1 (0.7-1.8) kg had the longest average transport length in the months from May- November with a movement of 13.2 m (Table 5), a longer travel distance compared with station 1.

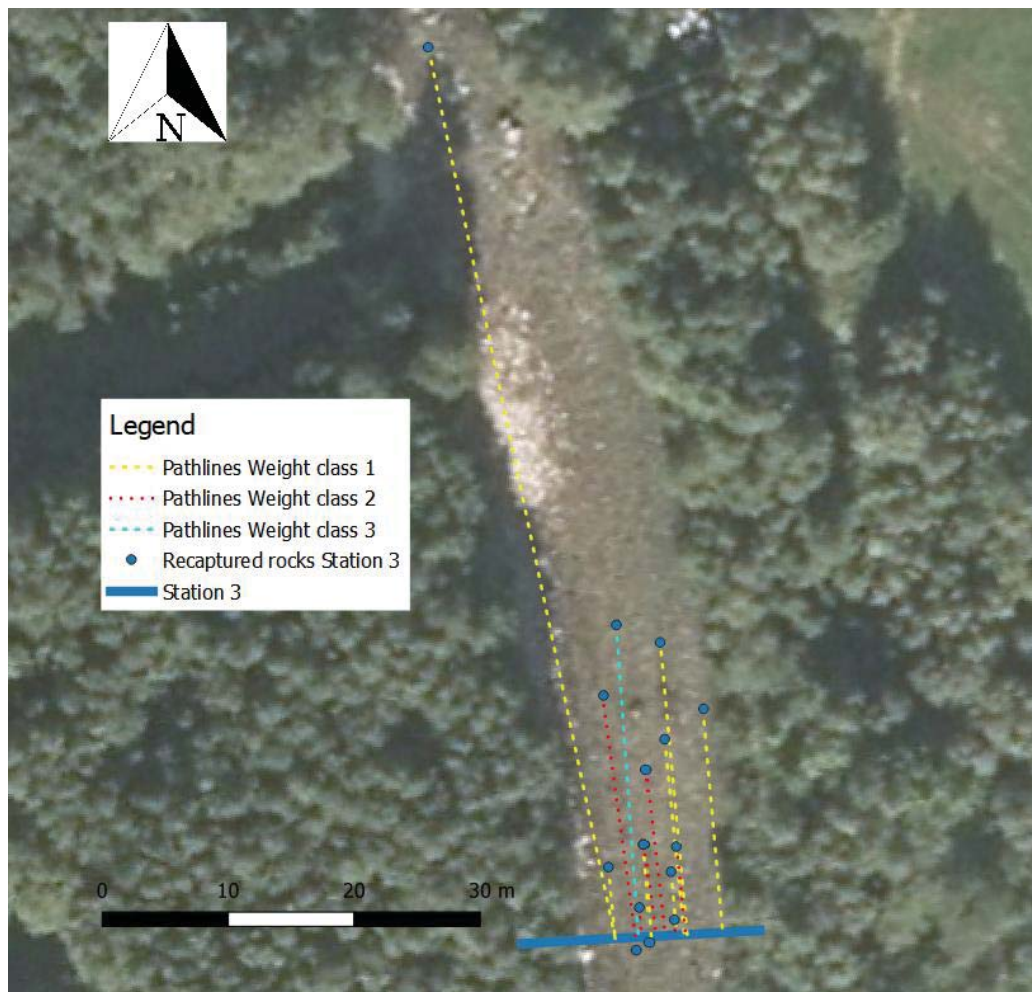
Figure 9. Overview map showing travel path for traced rocks at station 3. The blue starting line is where rocks were released, and blue dots are where they were recaptured. The colour of the path lines indicates what weight class each recaptured rock belongs to.

Station 3 represents the same restoration number as station 2 (Table 1, Appendix 1), and is located below the re-opened side-channel (Figure 2). A total of 19 rocks were released and 16 rocks were recaptured, a recovery rate of 84%. As seen on Figure 10 below, two of the rocks were mistakenly thrown above the starting line and have no registered travel distance. Figure 10 shows the travel path for each rock from when it was released, till it was recaptured. In contrast to station 1 and 2, weight class 3 (1.8-2.5 kg) had the longest average transport distance in the months from May- November with an average movement of 24.7 m (Table 6).

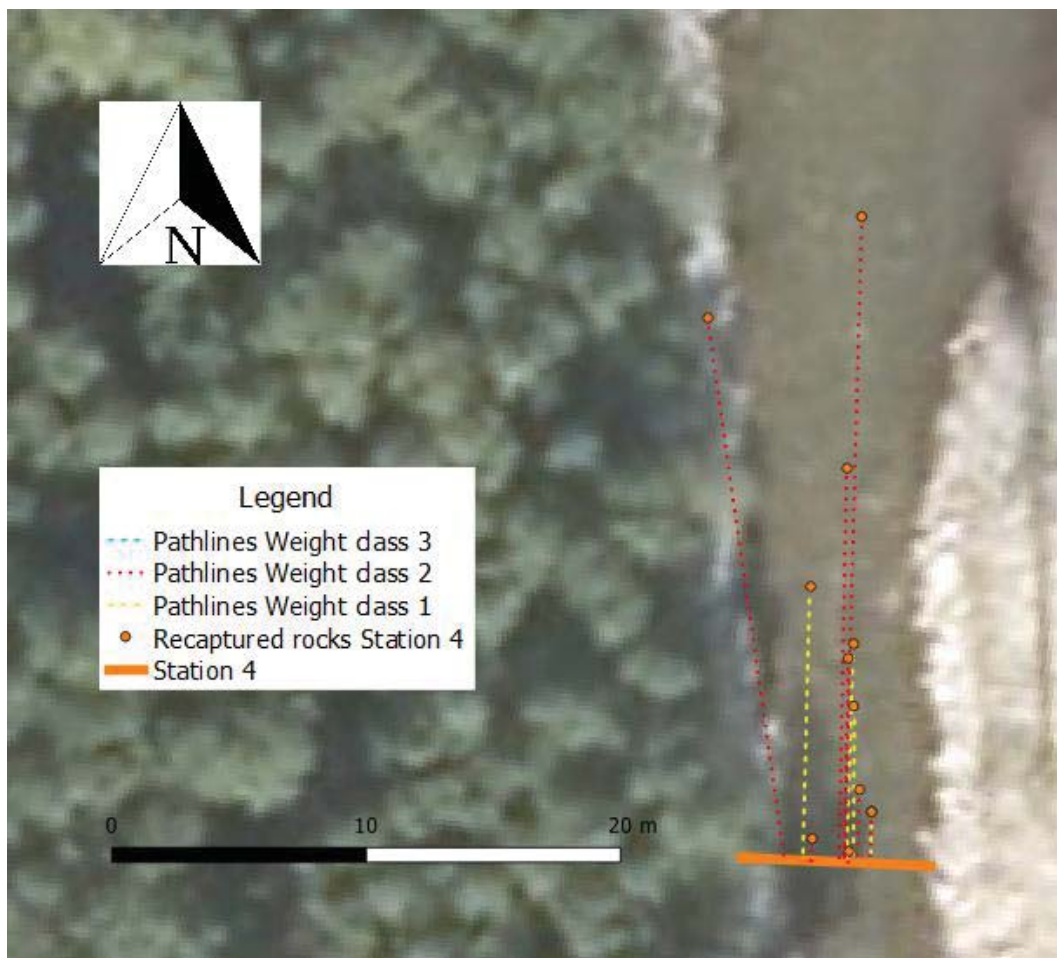
*Figure 11. Overview map showing travel path for traced rocks at station 4. The orange starting line is where rocks were released, and orange dots are where they were recaptured. The colour of the path lines indicates what weight class each recapture rock belongs to.*

Station 4, was the furthest station downstream, and was related to measures conducted in 2014, where an island was constructed (Figure 2) (Table 1). A total of 14 out of 19 rocks were recaptured, a recovery rate of 73.6%, lower than station 1-3. Figure 11 shows the travel path for each rock from when it was released, and until it was recaptured. Weight class 2 (0.7-1.8 kg) had the longest average transport length in the months from May- November, with 8.06 m, but shorter travel distance than the other stations (Table 7).

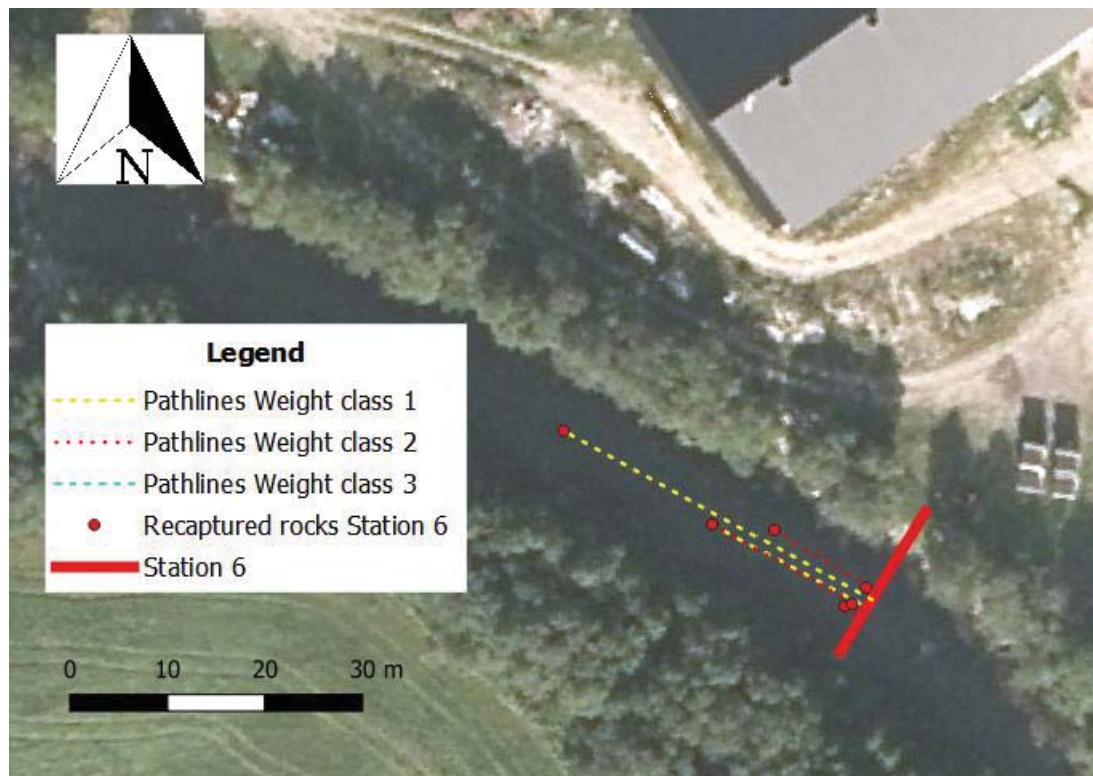
Figure 12. Overview map showing travel path for traced rocks at station 6. The red starting line is where rocks were released, and red dots are where they were recaptured. The colour of the path lines indicates what weight class each recapture rock belongs to.

Station 6 is one of two reference stations sampled where the river was still channelized, and where no restoration measures have been conducted (Figure 2). A total of 7 out of 19 rocks were recaptured 6<sup>th</sup> November, a low recovery rate of 36.8 %, lower than the other stations with recaptured data. Figure 12 below shows the travel path for each rock at station 6 from when it was released, and until it was recaptured. Weight class 1 (0.7-0.7 kg) had the longest average transport length in the months from May- November with 24.1 m.

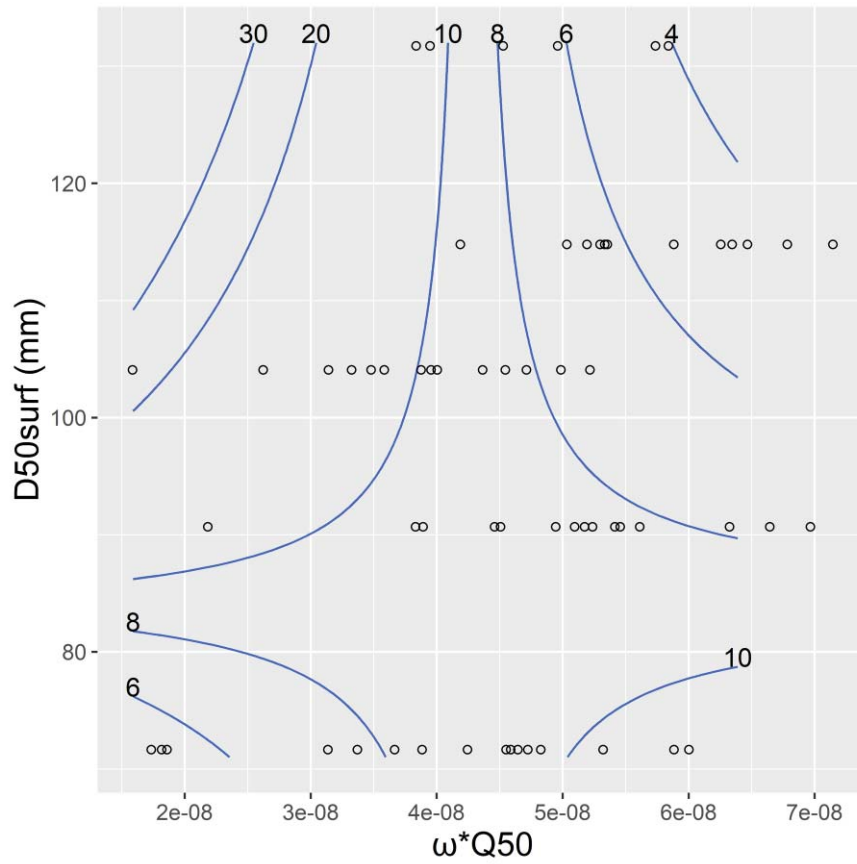
Figure 13: Contour plot of estimated values of transport distance. The contour lines represent estimated travel distance values for different dimensionless stream power ( $\omega*Q50$ ) and different median size of the bed surface sediment ( $D50_{surf}$ , mm). All the dots represent the data values, while the lines represent the model. Values in the plot are based on values from Table 9 and 10. Note that  $\omega*Q50$  values are in small numbers due to millimetre size of rocks and substrate.

Even though model predictors were statistically significant, the selected model had a low prediction precision of  $R^2=0.086$ .

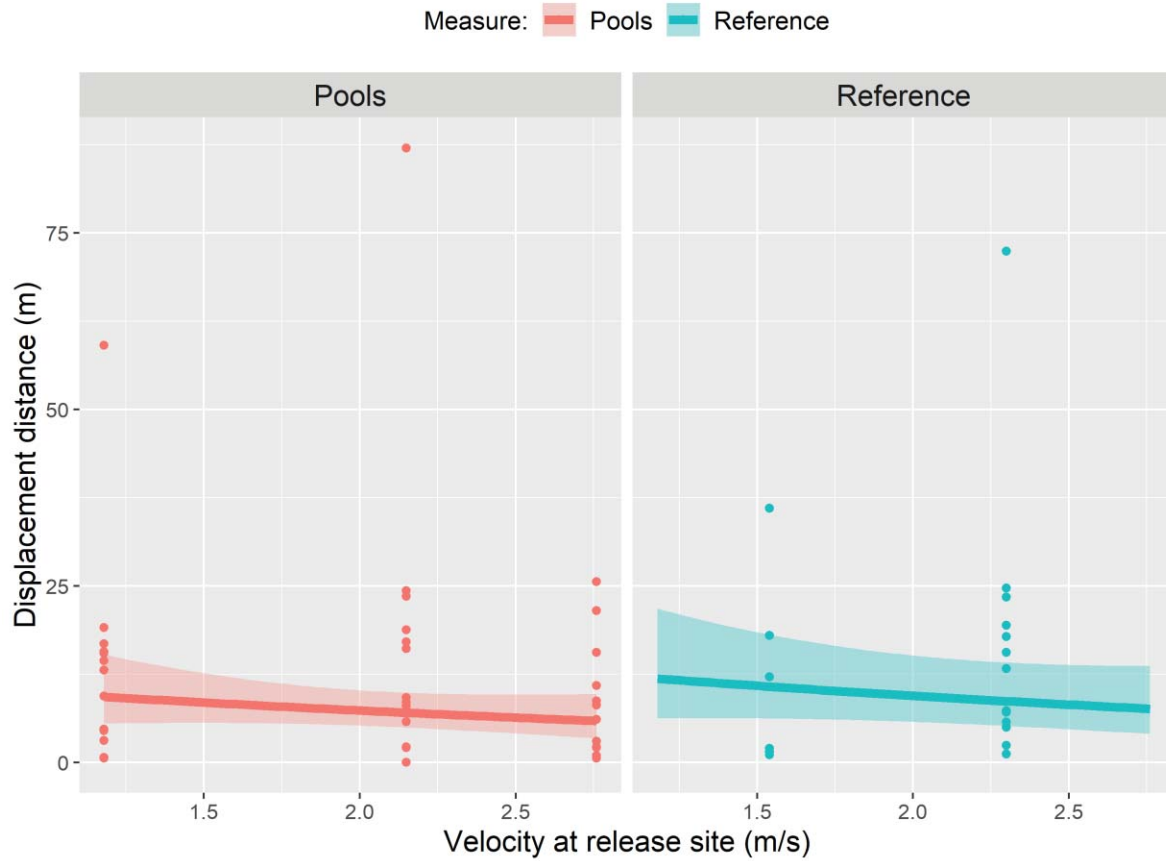
Figure 14. Prediction plot of model 9 that contains highest effect of river restoration measure (with 95% confidence interval). A predicted probability for rock distance at different velocities within pools and reference areas. The dots represent the recaptured rocks. Velocity at release site (m/s) was measured once in October 18<sup>th</sup>, 2019.

Even though the model predictors were not statistically significant, with a low prediction precision of  $R^2=0.03$ , the model shows a tendency where the rocks have longer travel distance in reference areas than pools.

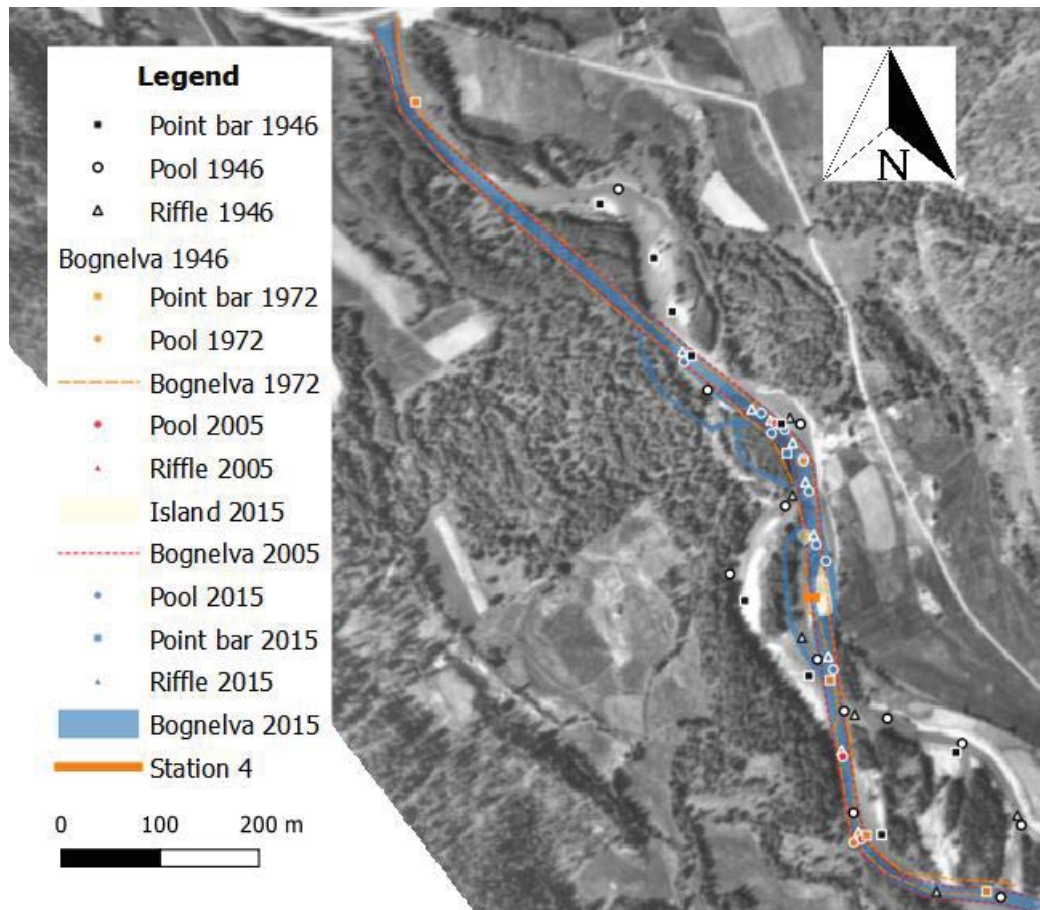
*Figure 15. Observed morphological features such as channel outline, point bars, pools, riffles and islands from 1946-2015. Background photo is from 1946, while orange, red and blue outlines are from 1972, 2005 and 2015, respectively. Station 4 was the lowest furthest station down the river where traced rocks were released in May 2019.*

Figure 15 shows an overview over all observed features and their location in the river channel from 1946-2015. Colour of the features are related to each year, where black colour is linked to 1946, orange to 1972, red to 2005 and blue to 2015. The overview map was simplified and analysed year by year. The result of the aerial photographs analysis was synthesised in a general scheme (Table 12) in the end of this chapter that summarizes the main styles of morphological adjustments observed in Bognelva before channelization, after channelization and after river restoration. The scheme represents initial intermediate and final stages of channel adjustment and relating morphologies. All four original orthophotos can be seen in Appendix 6.

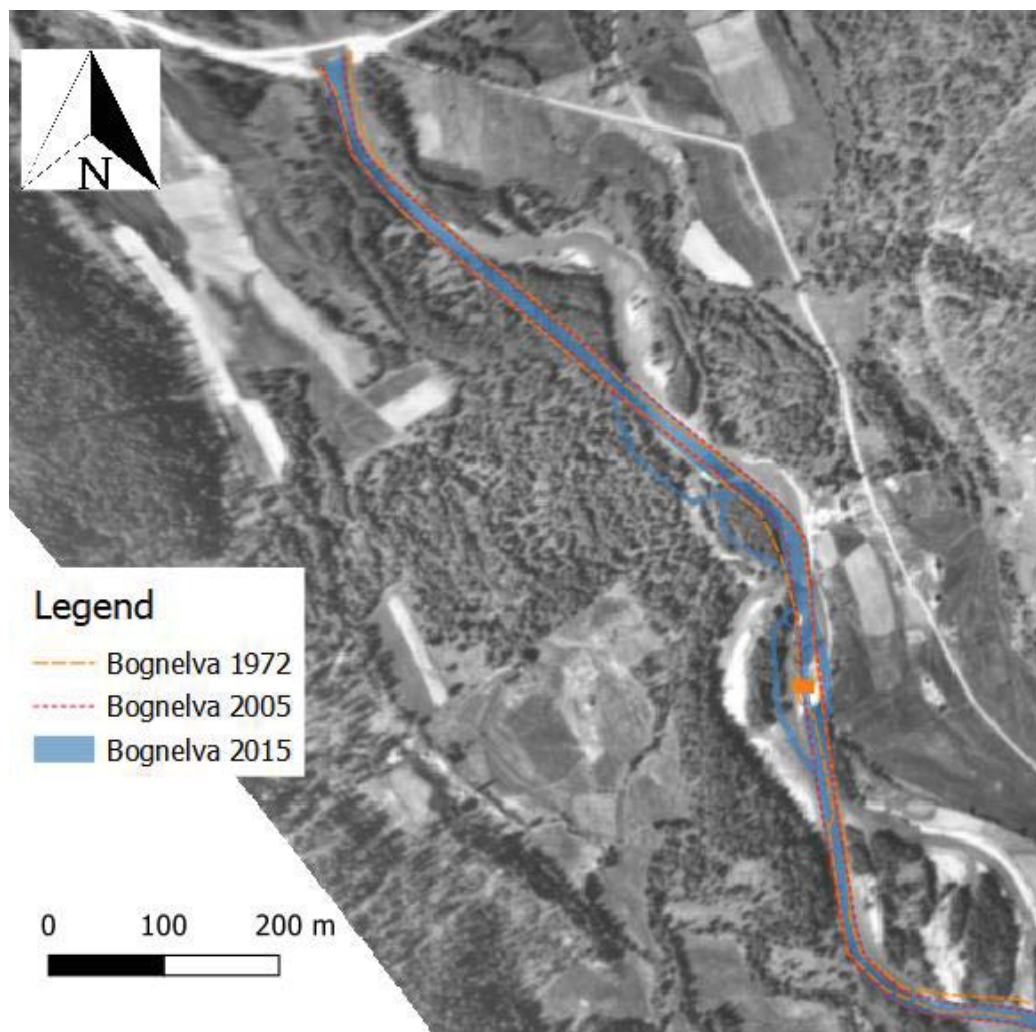
*Figure 16. Changes in channel outlines from 1946-2015. Background photo is from lower Bognelv in 1946. Orange dotted line shows where the channel outline was located in 1972, red dotted line from 2005, and blue river polygon shows the channel outline from 2015.*

Orange and red channel outlines from 1972 and 2005 illustrate how the river channel was channelized, and how meandering turns and side channels were cut off. After 2005, river restoration was conducted and the blue channel outline shows how restoration measurements re-opened some side channels.

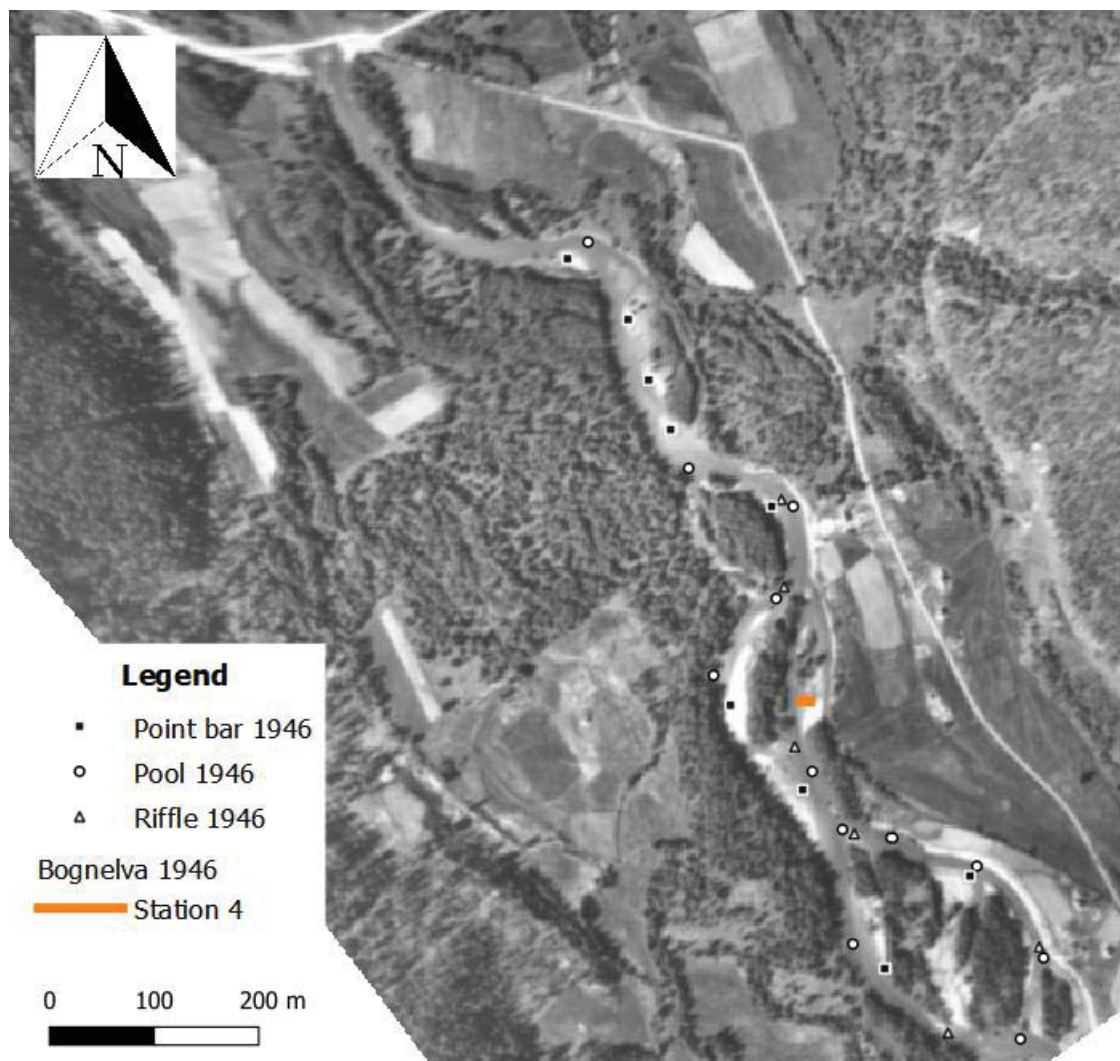
Figure 17. Aerial photo of Bognelva in 1946. Observed morphological features have been marked, such as point bars, pools and riffles. Station 4, shown as a reference point to where rocks were released in May 2019, at the station located furthest down and in a restored section of the river.

Figure 17 below shows a dynamic meandering river with nine assumed point bars. The erosion in the outer turn creates pools, and the stream type will be classified as pool-riffle sequence (Montgomery and Buffington, 1997). It can also be observed side channels, islands, and the river is in general wider and longer than in the later years (Table 12). There was approximately similar amount of pools ( $n=11$ ), point bars (sediment bars,  $n=4$ ), and islands ( $n=9-10$ ). Number of riffles were not as high as the other features. This can be due to a more stable water flow, where water level was probably higher.

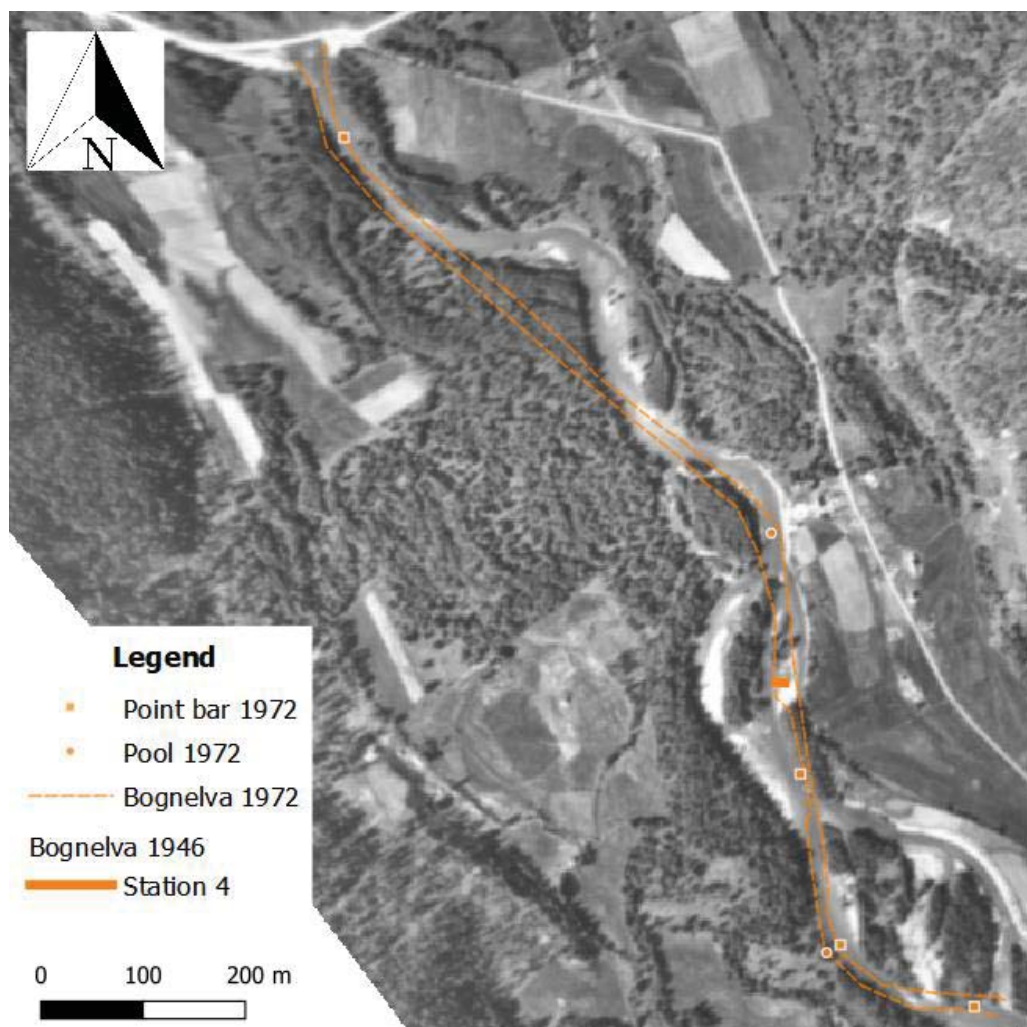
*Figure 18. Aerial photo of the channel outline of Bognelva in 1972. Background map shows the channel outline in 1946. Observed morphological features have been marked, such as point bars and pools. Station 4 is shown as a reference point to where rocks were thrown out in May 2019, at the lowest restored river station*

Between 1946 and 1972, the length of the river and river width was shortened (Table 12). With the river straightening the hydromorphological numbers of features has also decreased. Pools decreased from 11 to 2, and point bars from 9-2 (Table 12). Those remaining were in similar location as in 1946. Note that no riffles, islands, or side channels can be observed in the 1972 photograph. Figure 18 shows how the river was located a good distance away from the original river channel. The dramatic change in morphology makes the river stream change classification from a riffle-pool sequence to a plane-bed sequence (Montgomery and Buffington, 1997).

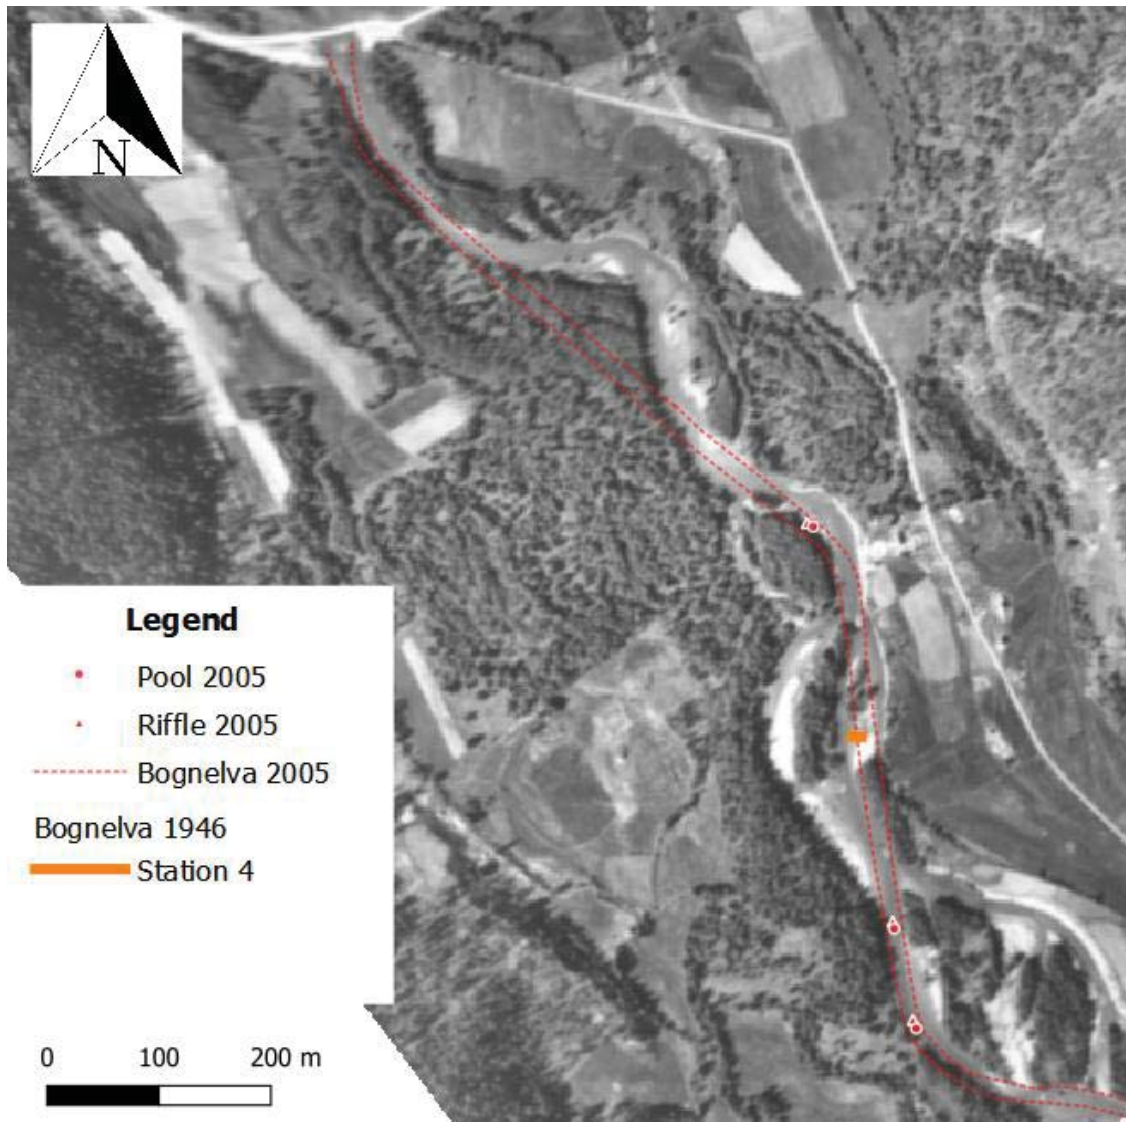
*Figure 19. Aerial photo of the channel outline of Bognelv in 2005. Background map shows the channel outline in 1946. Observed morphological features have been marked, such as pools and riffles. Station 4 is shown as a reference point to where rocks were released in May 2019.*

From 1972-2005 Bognelv was still under technical intervention. With the flood in 1978, the river was even more channelized. The average river width is getting smaller from 1972 and also the river length in this section. More riffles and pools are formed (Figure 19) (Table 12).

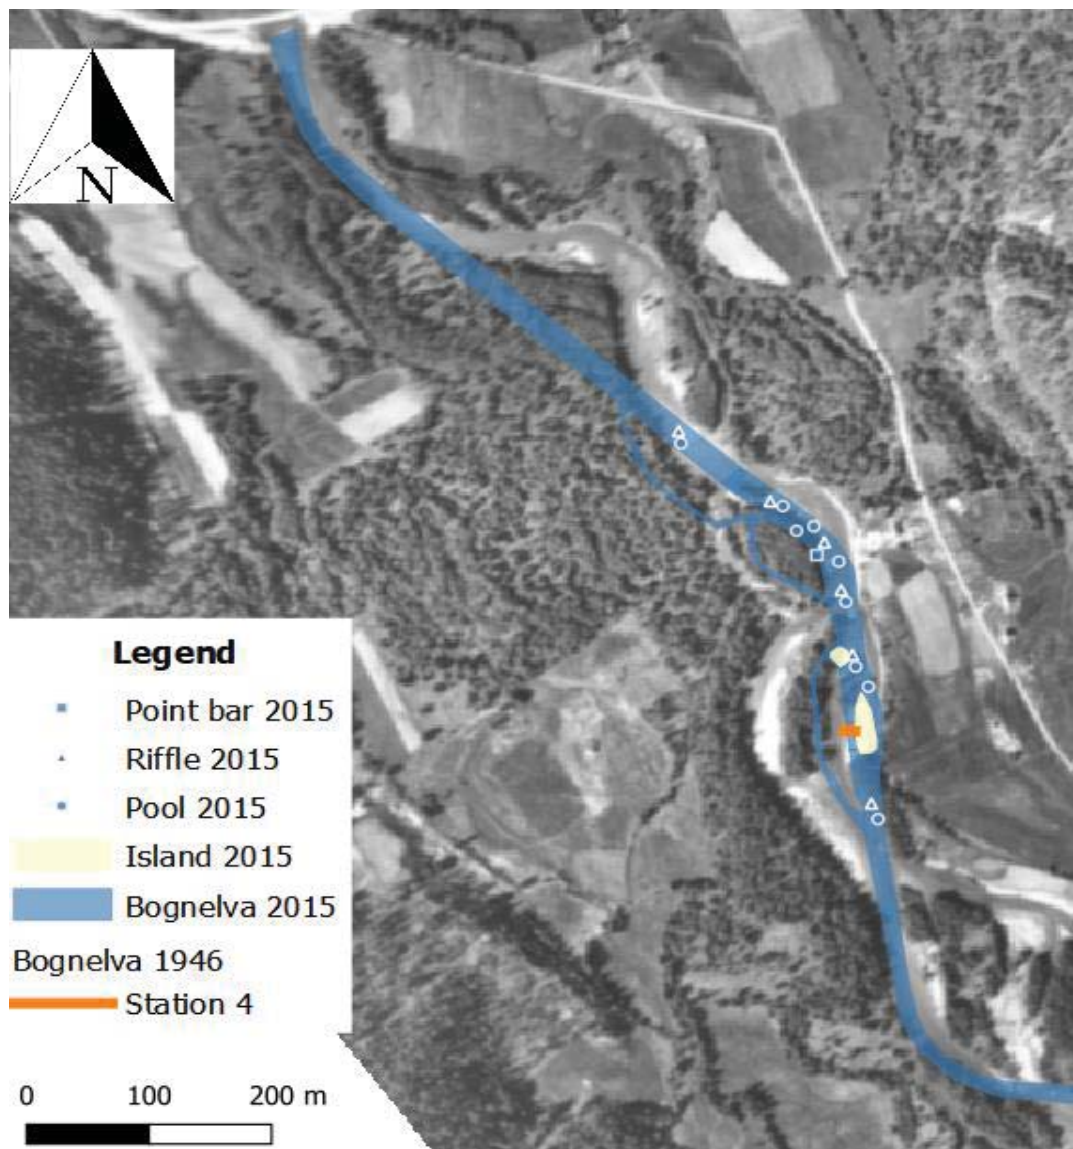
Figure 20. Aerial photograph of the channel outline of Bognelv in 2015. Background map shows the channel outline in 1946. Observed morphological features have been marked, such as point bars and pools. Station 4 is shown as a reference point to where rocks were released May 2019.

After 10 years with ongoing, various restoration measures, the aerial photo from Bognelv 2015 (Figure 20) revealed re-opening of side channels, constructed islands and formation of point bars, riffles and pools. The construction of the island and re-opening of side channels allowed the river to become more braided and meandering. River width and length has increased, in contrast from the years between 1972-2005 (Table 12).
